# **Failure Analysis of Paints and Coatings**

George T. Bayer, Ph.D.  
Mehrooz Zamanzadeh, Ph.D.

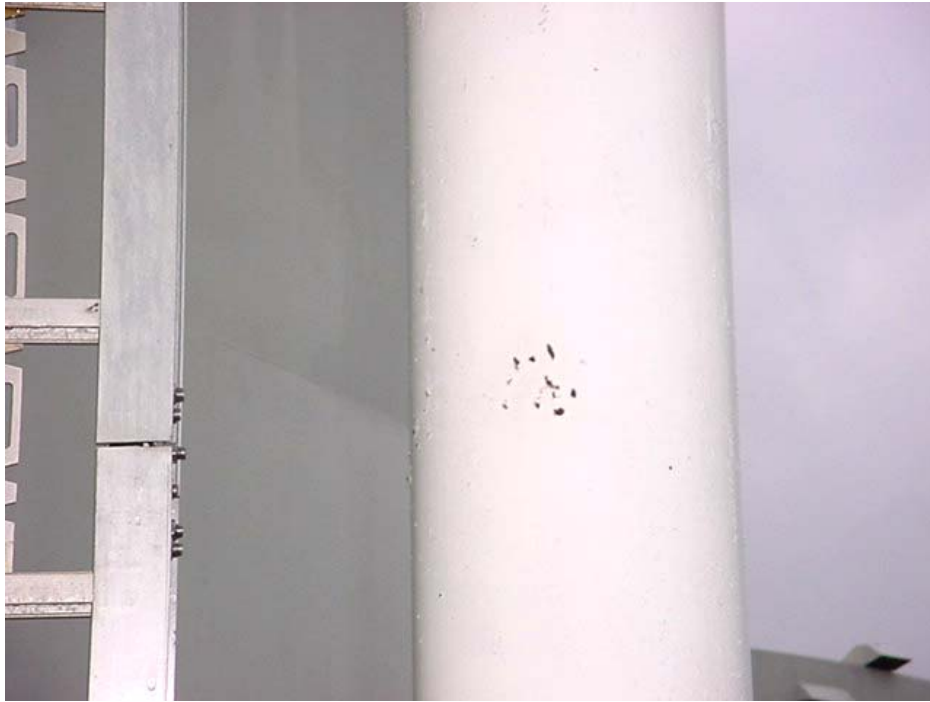
**Figure 1. Photograph of peeling paint from pipeline.**

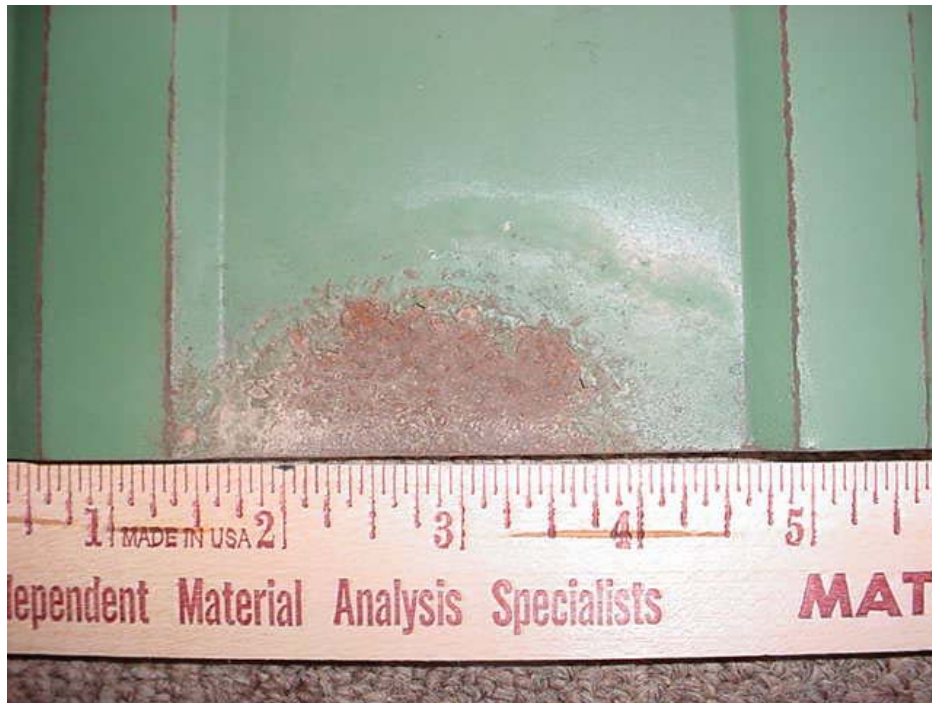
**Figure 8. Close-up photograph of red rust spot on green side.**

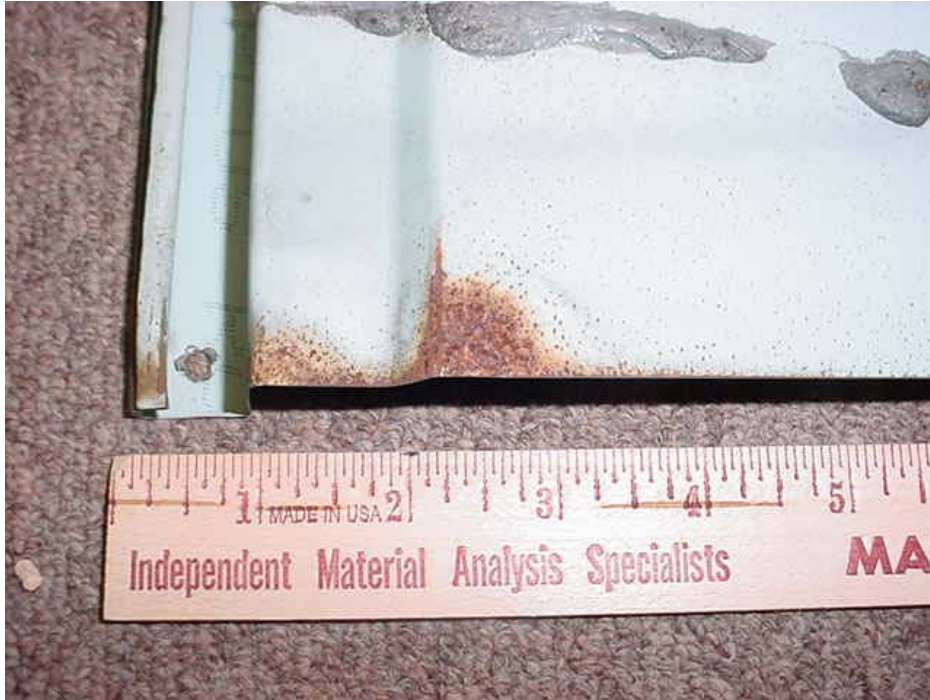
**Figure 9. Close-up photograph of red rust spot on light blue side.**

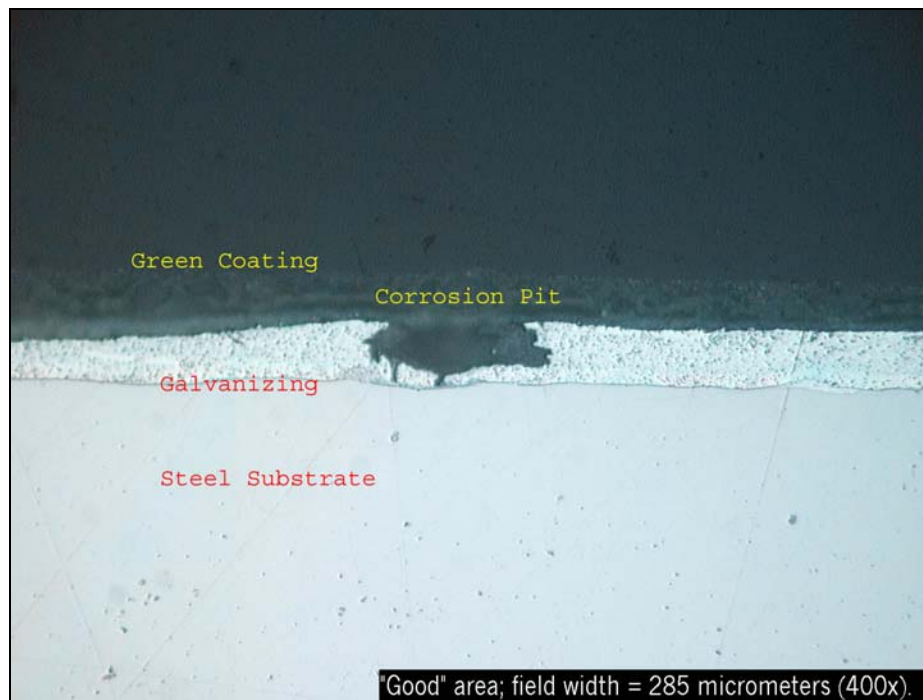
**Figure 10. Cross sectional optical micrograph of corrosion pit in galvanized layer under green coating; field width = 285 micrometers (400x).**

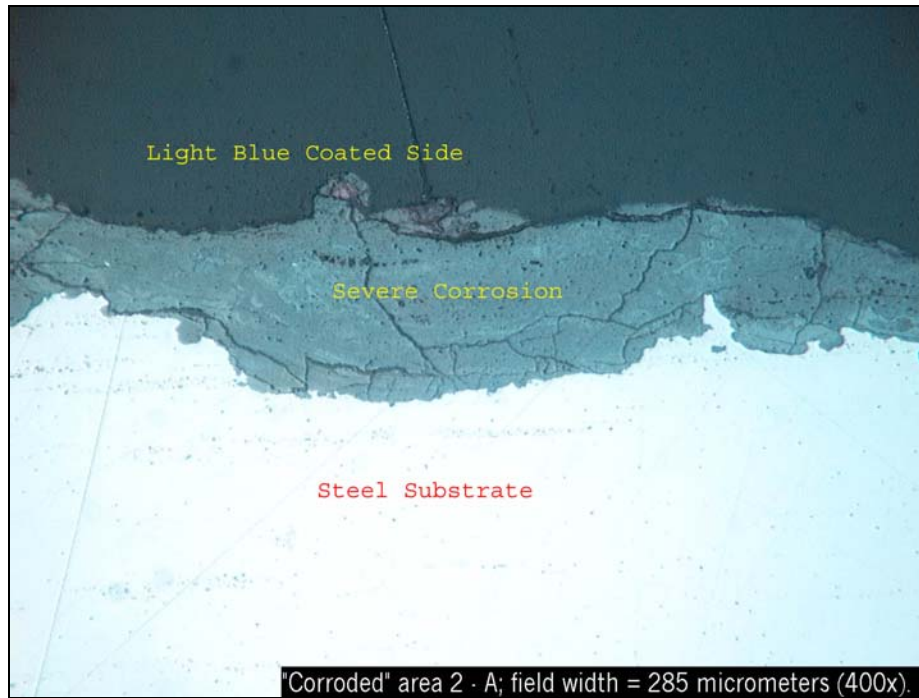
**Figure 11. Cross sectional micrograph of severe corrosion present on light blue side; field width = 285 micrometers (400x).**

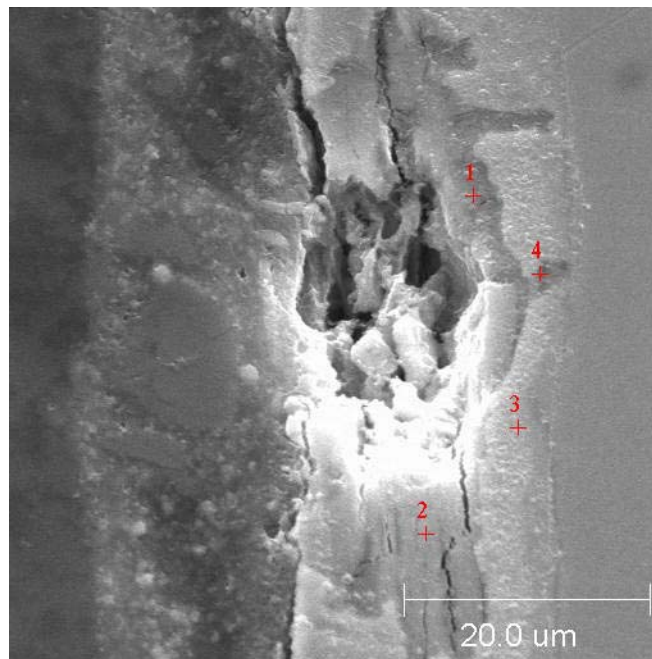
**Figure 12. Scanning electron micrograph of corrosion pit in “good” area with locations marked for EDS analysis.**

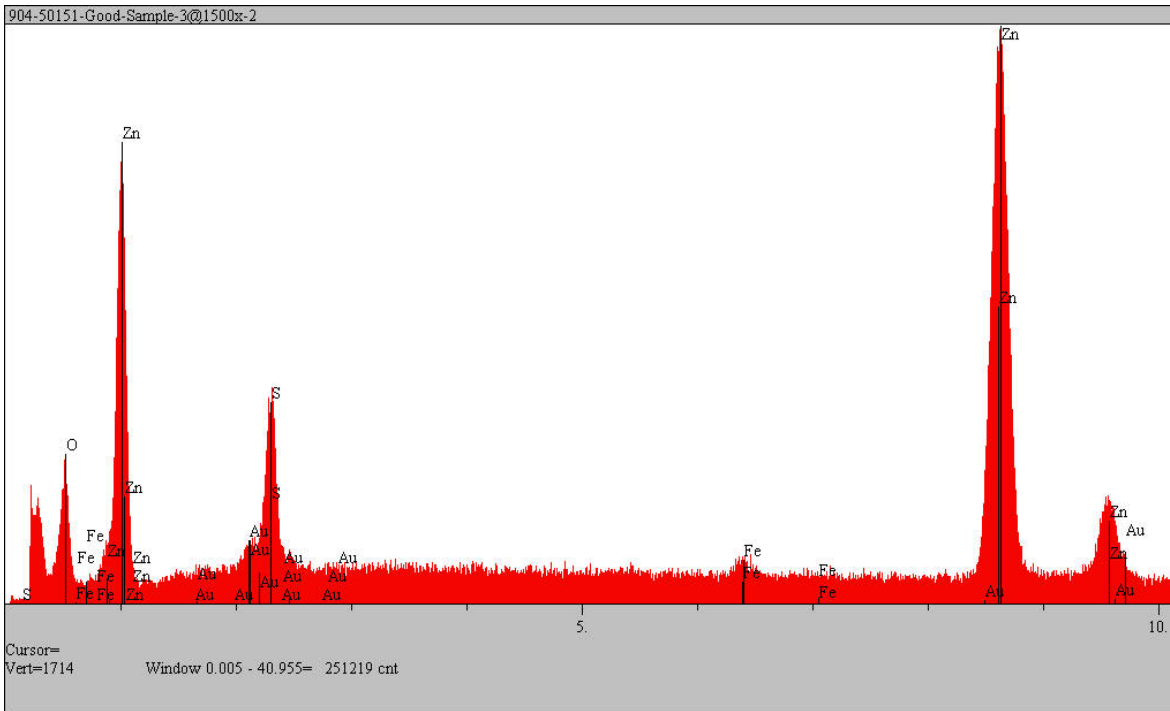
**Figure 13. EDS spectrum of location 2 from “good” area as shown in Figure 12.**

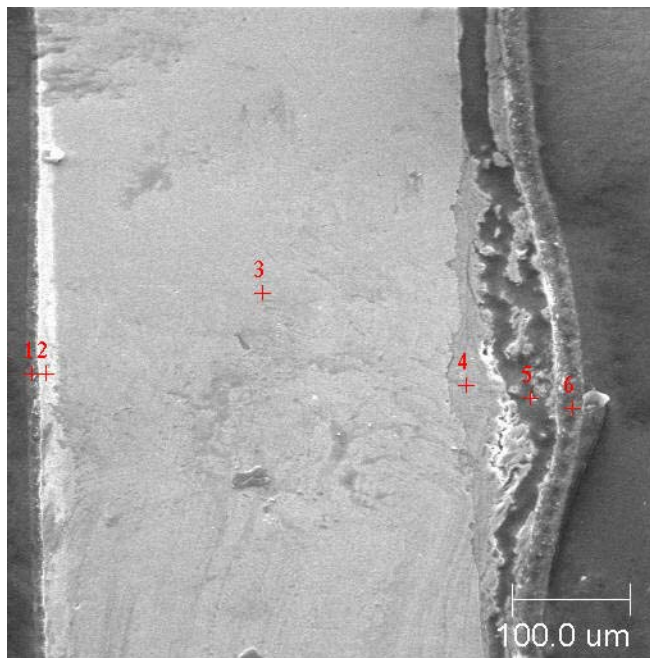
**Figure 14. Scanning electron micrograph of corroded area with locations marked for EDS analysis.**

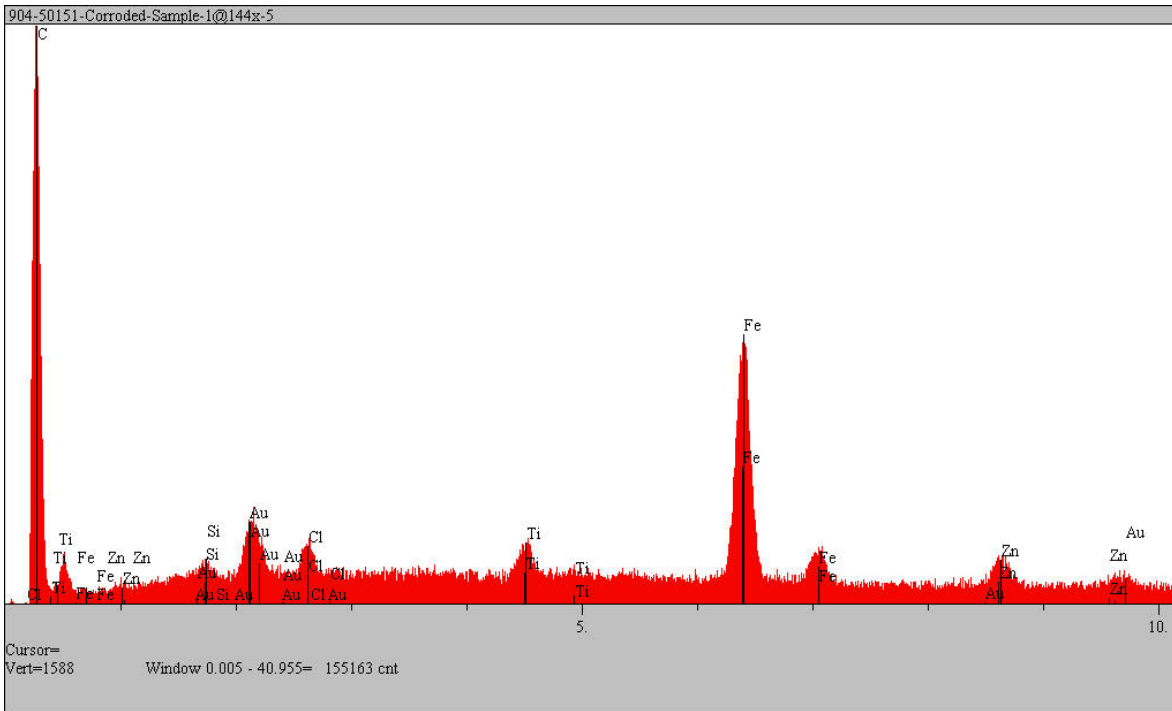
**Figure 15. EDS spectrum of location 5 from corroded area as shown in Figure 14.**

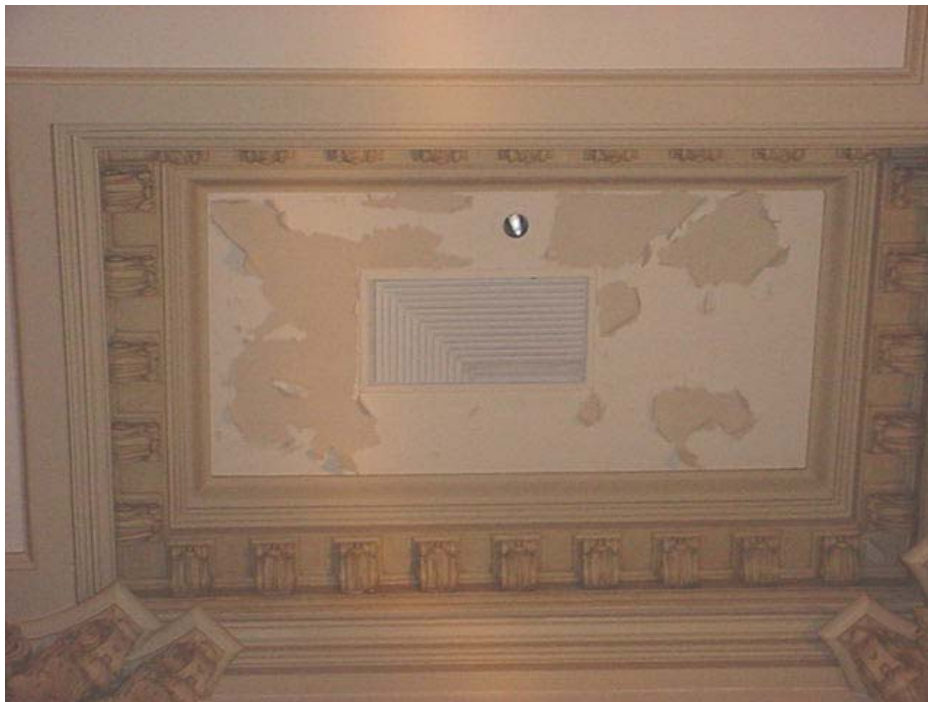
**Figure 16. On-site photograph; ceiling near vent.**

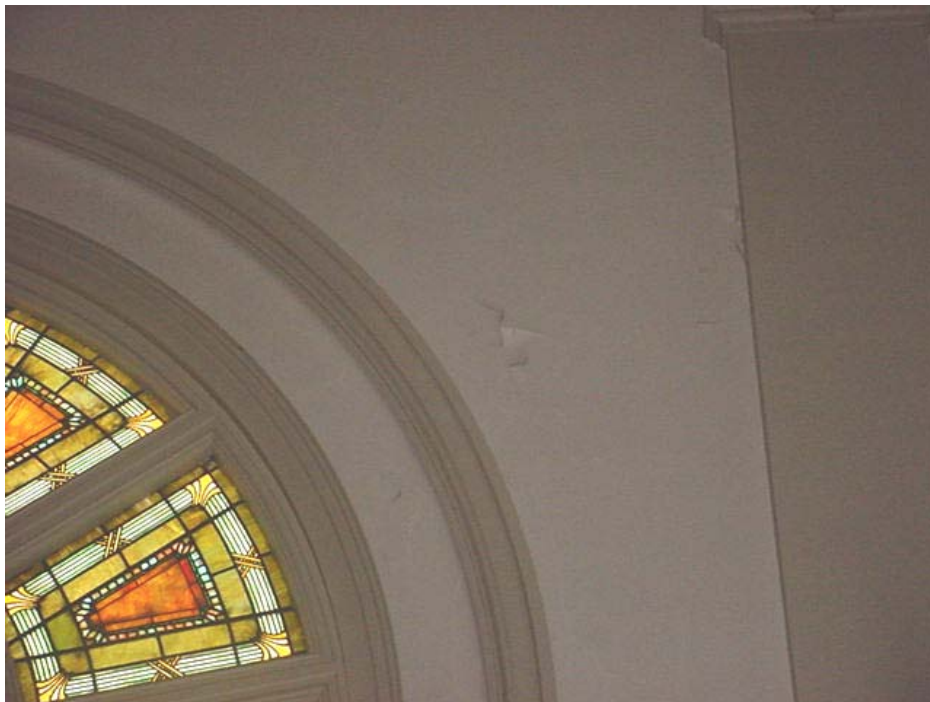
**Figure 18. On-site photograph; wall near stained glass window.**

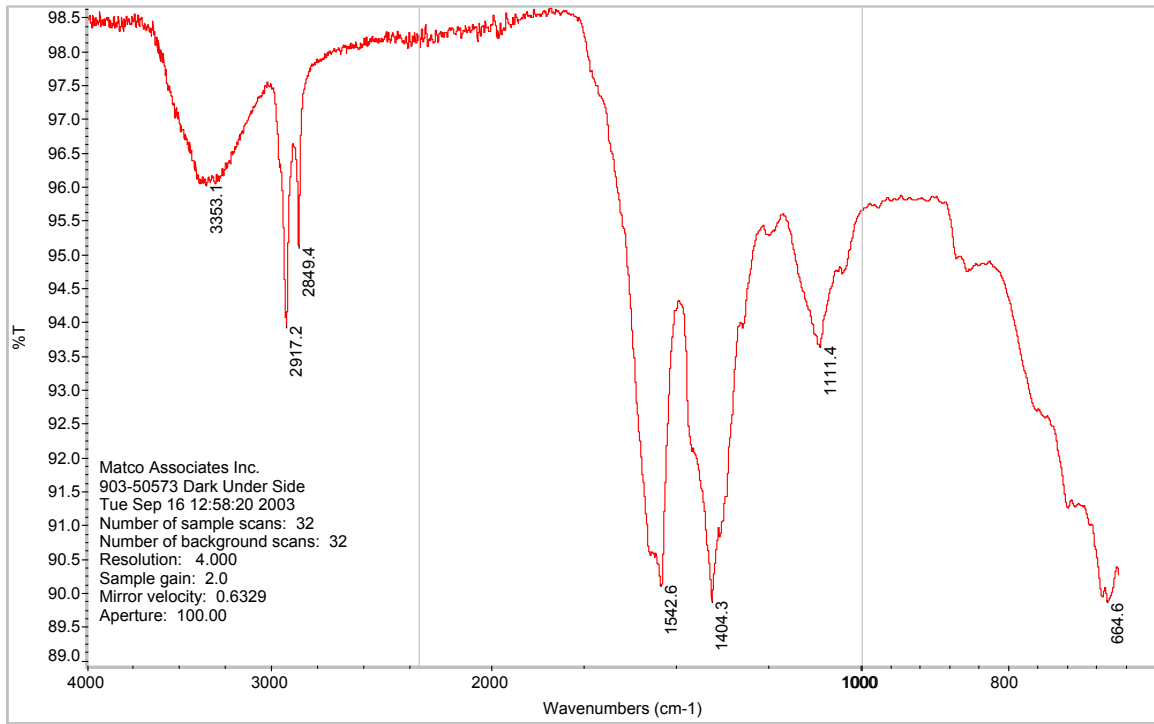
**Figure 19. FTIR spectrum of under side of dark peeled paint.**

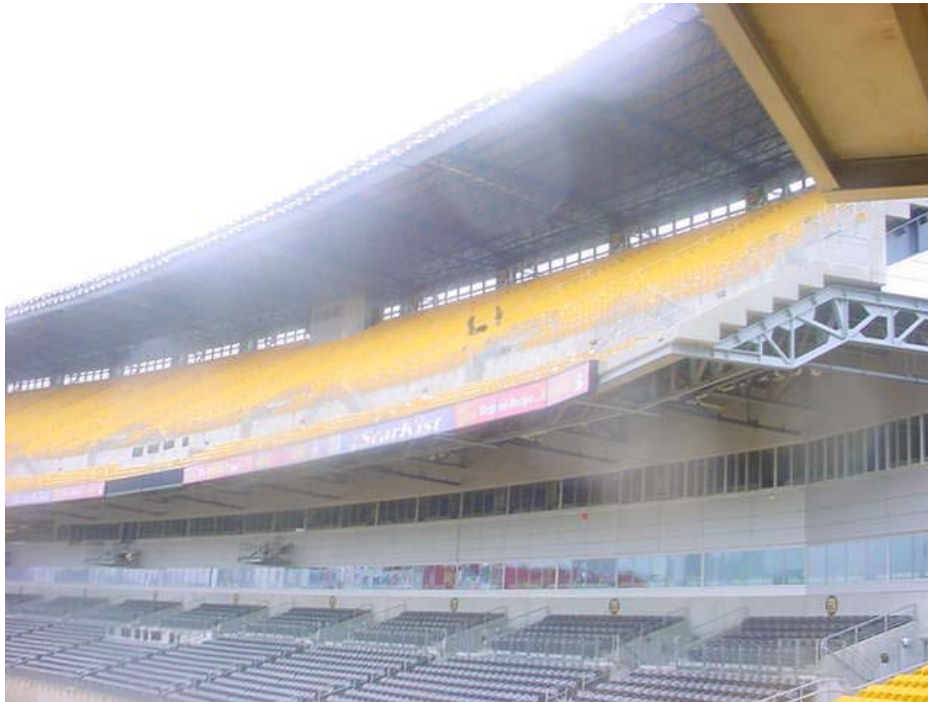
**Figure 20. Photograph of area of football stadium with failing yellow touch-up paint.**

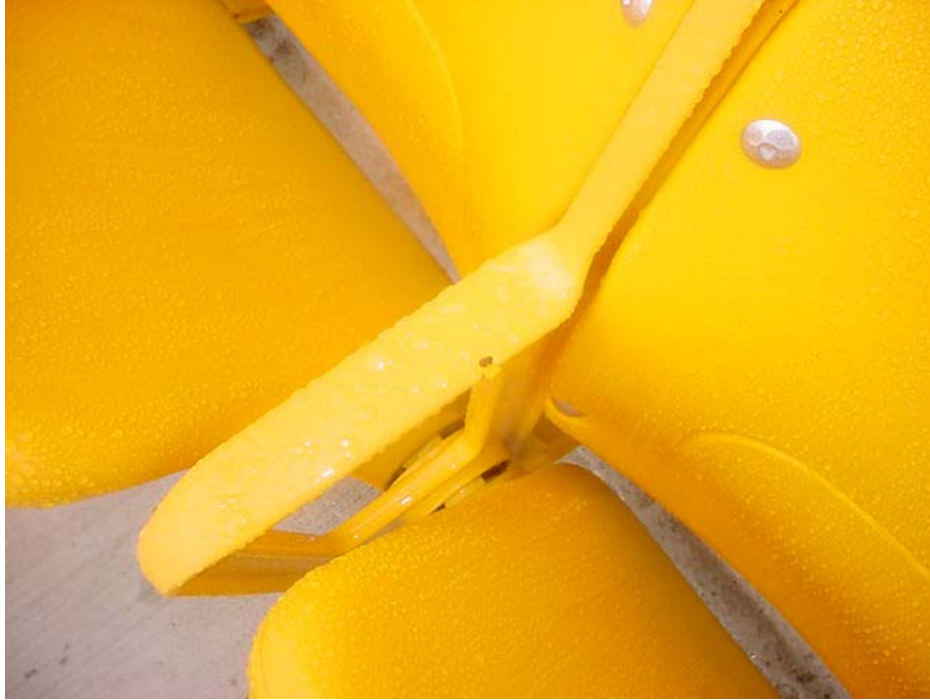
**Figure 21. Close-up field photograph of failed touch-up paint on seat standard.**

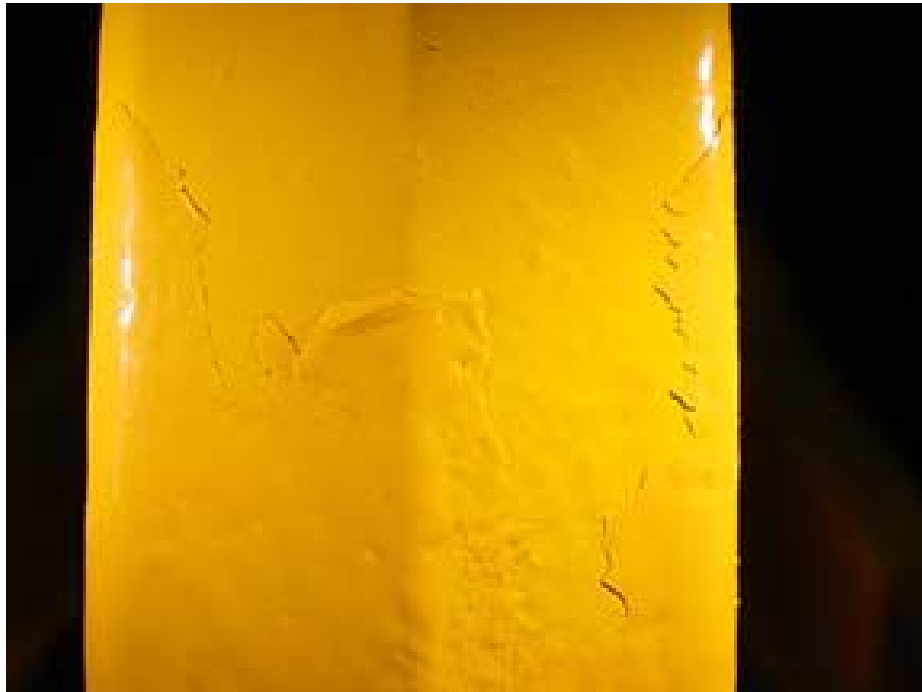
**Figure 22. Close-up laboratory photograph of peeling paint on seat standard.**

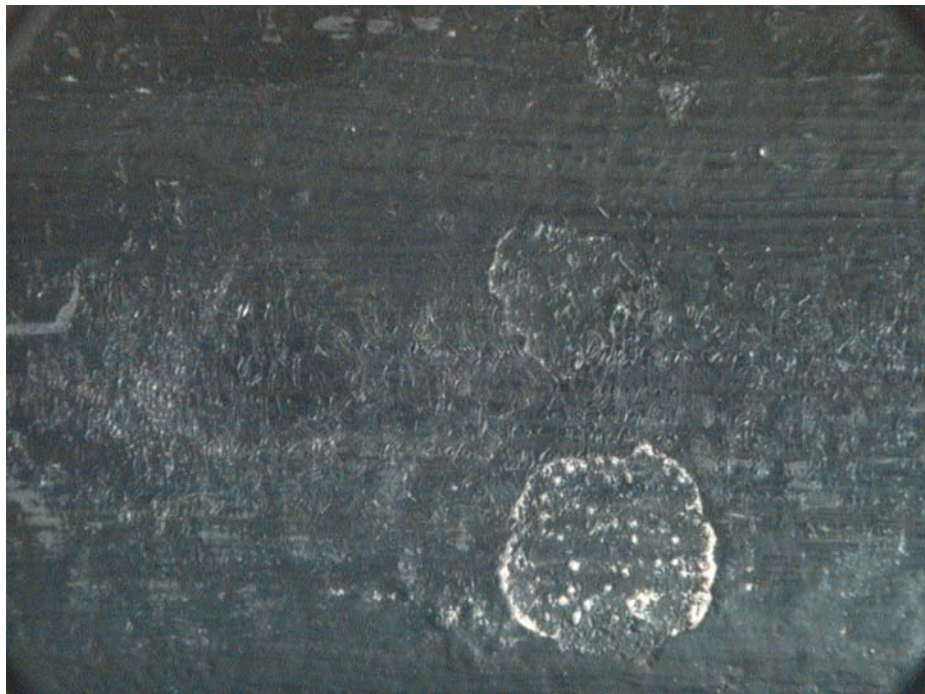
**Figure 26. Photograph showing a repaired blister area.**

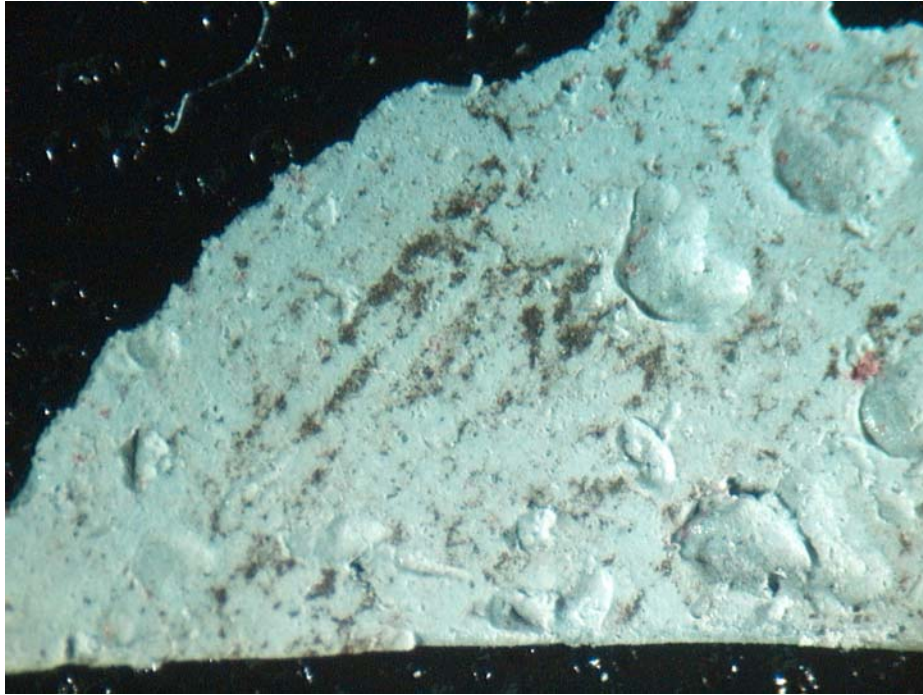
**Figure 27. Photograph at 10X showing particulate material on the primer underside.**

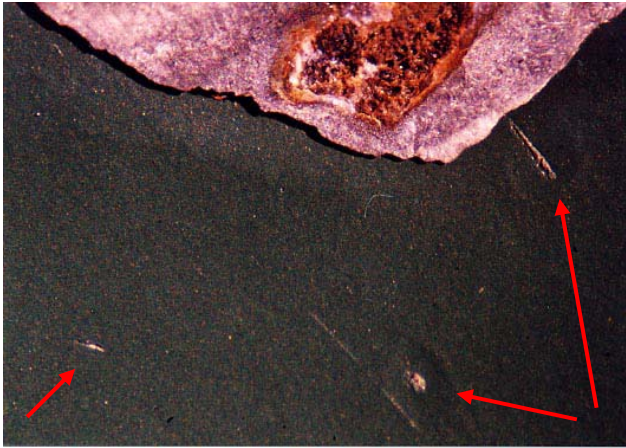
Mechanical Damage @ 15x

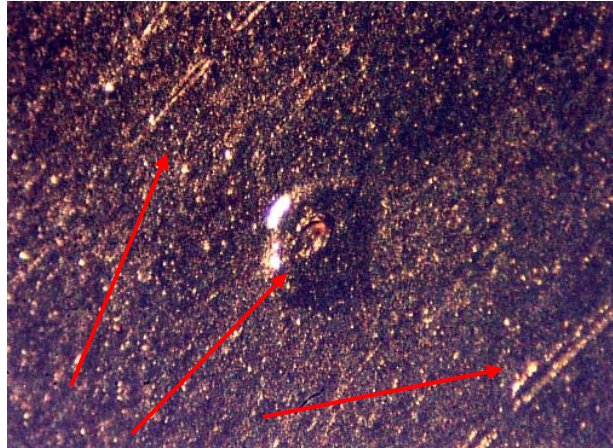
Mechanical Damage @ 22x

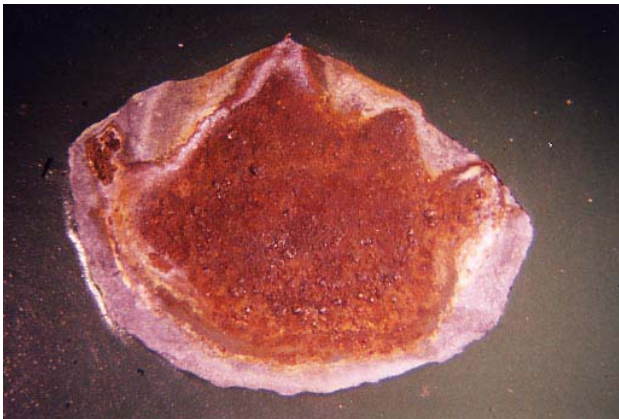
Sample #1 - Large Corrosion Pit @ 6x

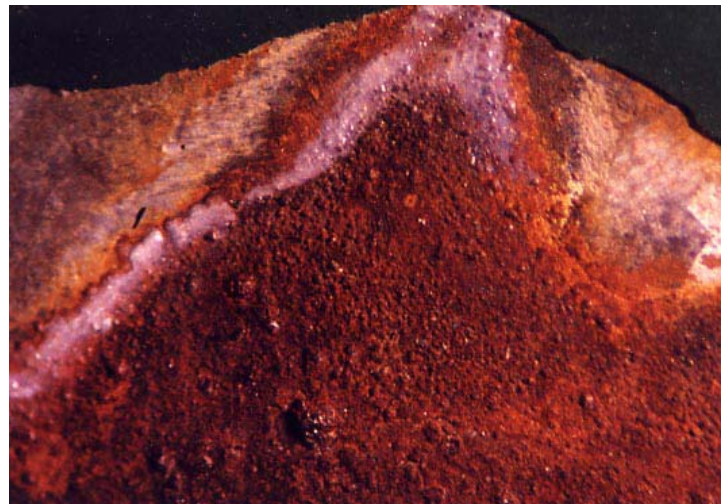
Sample #1 - Close-up of Large corrosion Pit @ 23x

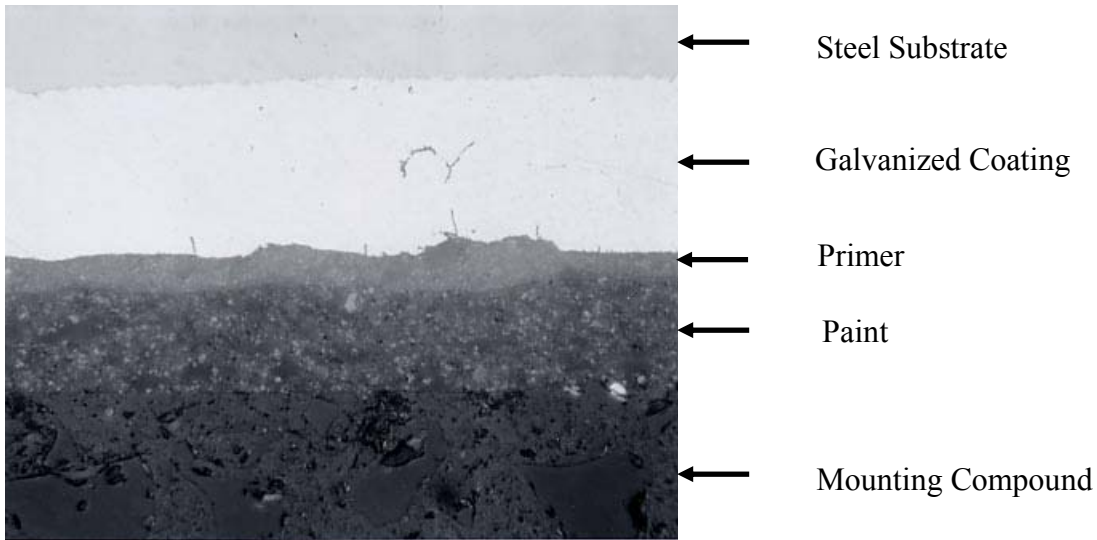
**Figure 35. Typical coating cross section at 100x magnification.**

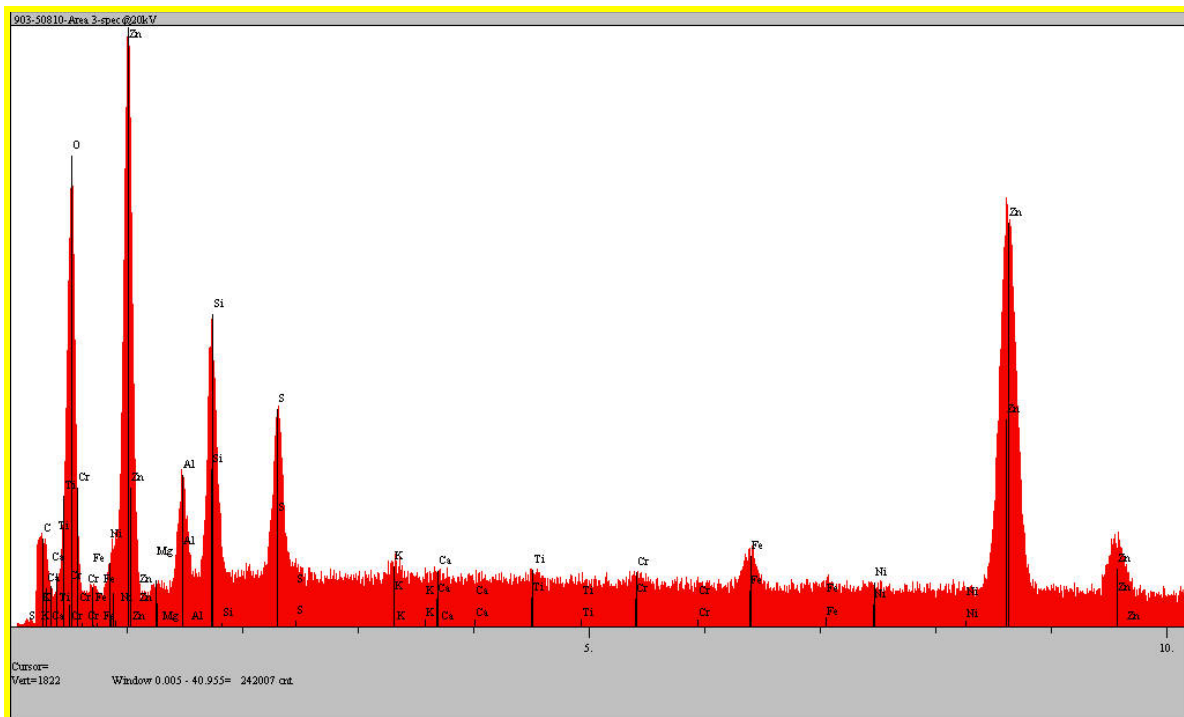
**Figure 36. EDS spectrum of outermost rim of corrosion pit showing high sulfur (S) levels.**
