## AIRCRAFT ACCIDENT REPORT

RUNWAY OVERRUN DURING LANDING  
AMERICAN AIRLINES FLIGHT 1420  
MCDONNELL DOUGLAS MD-82, N215AA  
LITTLE ROCK, ARKANSAS  
JUNE 1, 1999

**NTSB/AAR-01/02  
PB2001-910402  
Notation 7195A  
Adopted October 23, 2001**

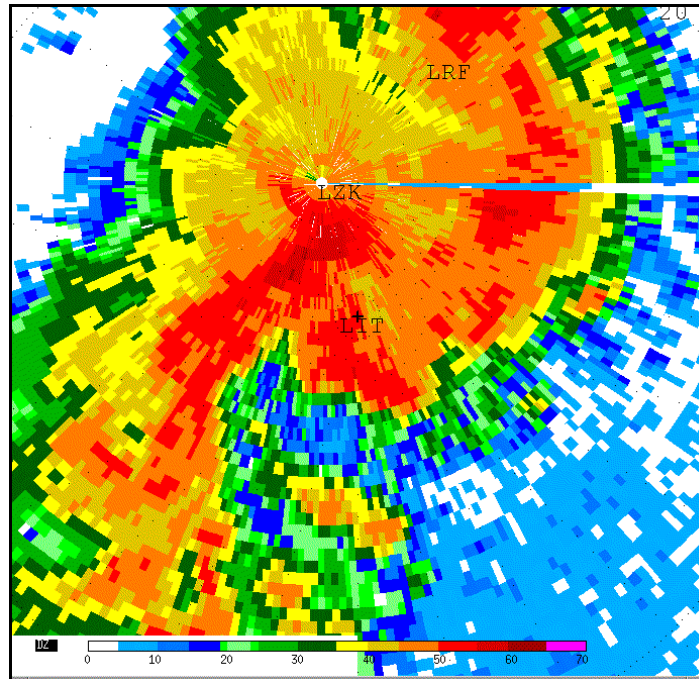
**Figure 9.** 0.4° Base Reflectivity Scan at 2345:57

The WSR-88D's 0.4° elevation scan of base reflectivity that was completed at 2345:57 indicated that the area over the airport and the approach end of runway 4R reached reflectivities of 54 dBz, or level 5 (intense) activity, and that the area approximately 5 miles west of runway 4R reached maximum reflectivities of 61.5 dBz, or level 6 (extreme) activity. Figure 9 shows the base reflectivity product for this time period.

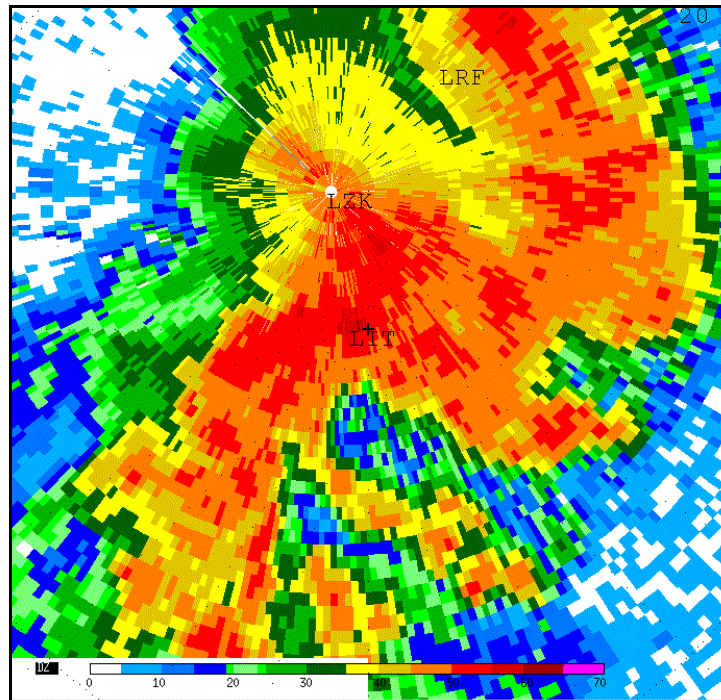
Figure 10. 0.4° Base Reflectivity Scan at 2351:59

At 2351:59, the 0.4° base reflectivity image depicted a maximum of 52 dBz, or level 5 (intense) activity, along the flight track, with maximum reflectivities of 60 dBz, or level 6 (extreme) activity, located 1 1/2 miles to the northwest. Figure 10 shows the base reflectivity product for this time period. Also, the 1.5° elevation scan at 2353:03 indicated returns of 58 dBz, or level 6 activity, with maximum reflectivities of 62.5 dBz 1/2 mile from the approach end of runway 4R.

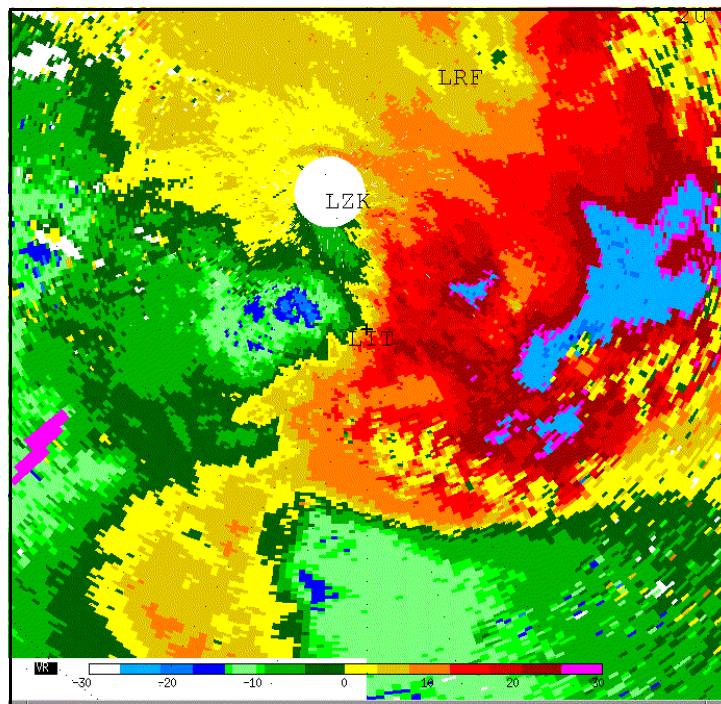
Figure 11. Radial Velocity Image Surrounding the Time of the Accident

The WSR-88D's radial velocity image (showing components of the wind speed that are coming directly toward or away from the radar) for 2346:29 indicated that winds from the northwest at 15 meters per second (30 knots) were over runway 4R. Figure 11 shows the radial velocity image for this time period with the airplane's flight track. At 2352:30, the radial velocity image depicted winds from the northwest at 18 meters per second (36 knots) over the runway with winds reaching 30 meters per second (60 knots) within 1/2 mile of the approach end of the runway.

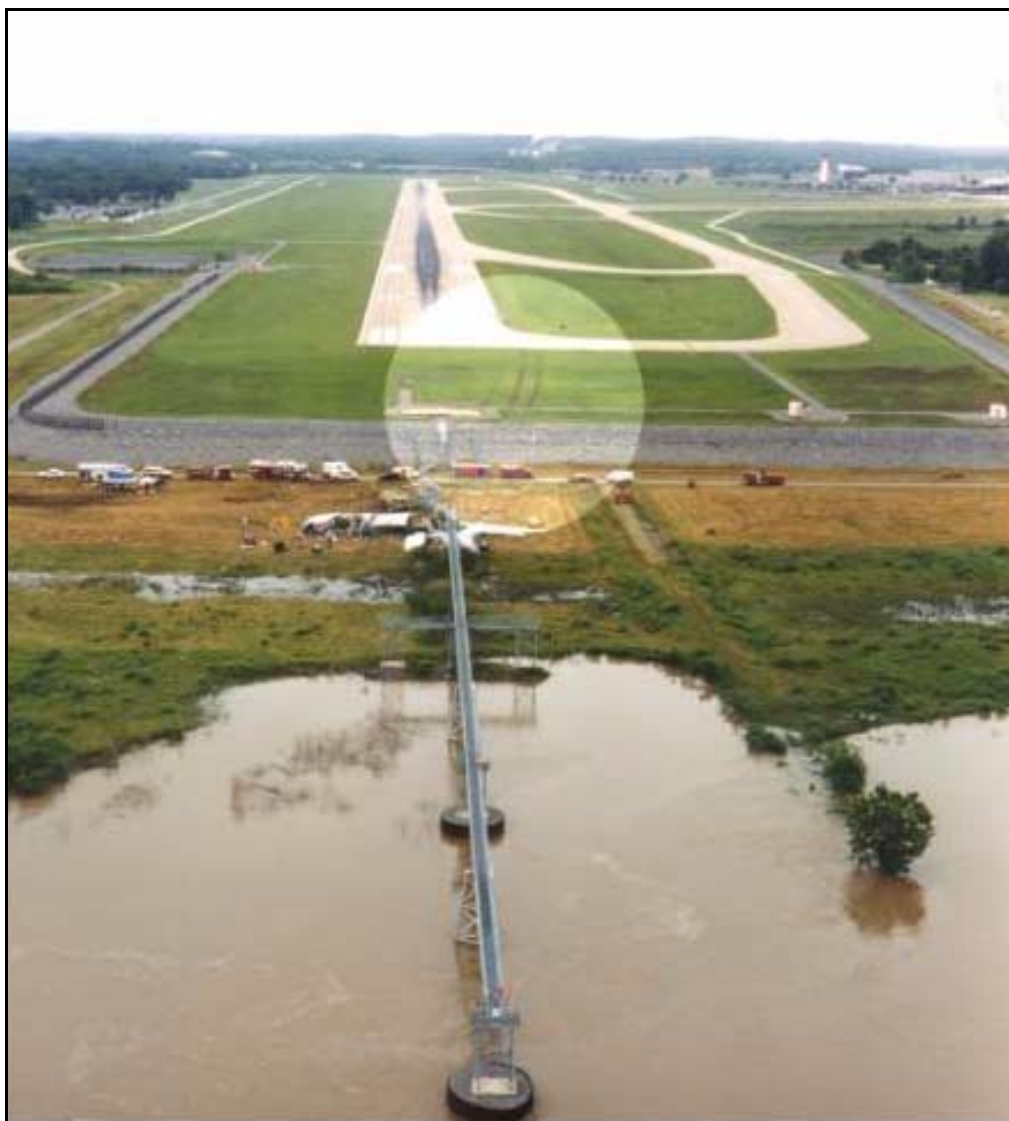
**Figure 12.** Aerial Photograph of Runway 4R/22L, Airplane Wreckage, and Runway 22L Approach Lighting System

The airplane destroyed several tubes extending outward from the left edge of the runway 4R ILS localizer array, part of a chain link security fence, and approximately 250 feet of the runway 22L approach lighting system support structure and walkway. The damage was estimated at \$325,000.

Figures 12 through 14 are photographs of the airplane wreckage. Figure 12 shows the airplane wreckage, the tire tracks off the end of runway 4R, and the damage to the runway 22L approach lighting system.<sup>77</sup> Figure 13 shows the airplane wreckage and the runway 22L approach lighting system. Figure 14 shows a closer view of the airplane and the runway 22L approach lighting system. Additional details about the airplane wreckage are presented in sections 1.12.2 through 1.12.4.

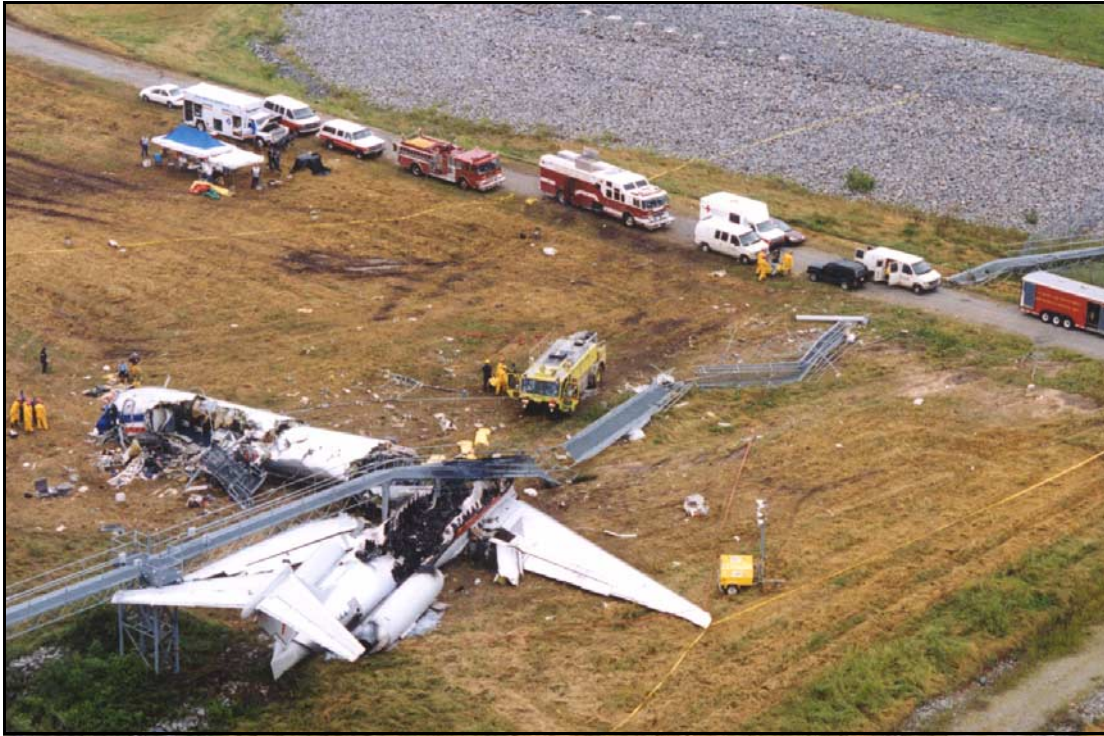
**Figure 13.** Airplane Wreckage and Runway 22L Approach Lighting System

<sup>77</sup> The runway 22L approach lighting system is supported by steel columns or platform assemblies that include steel columns. Five steel columns and two platform assemblies were struck by the accident airplane during its overrun. Each of these seven support structures was spaced 50 feet apart along a line that coincided with the centerline of runway 4R/22L. The first support structure was located about 530 feet from the end of the runway, and the seventh was located 830 feet from the end of the runway.

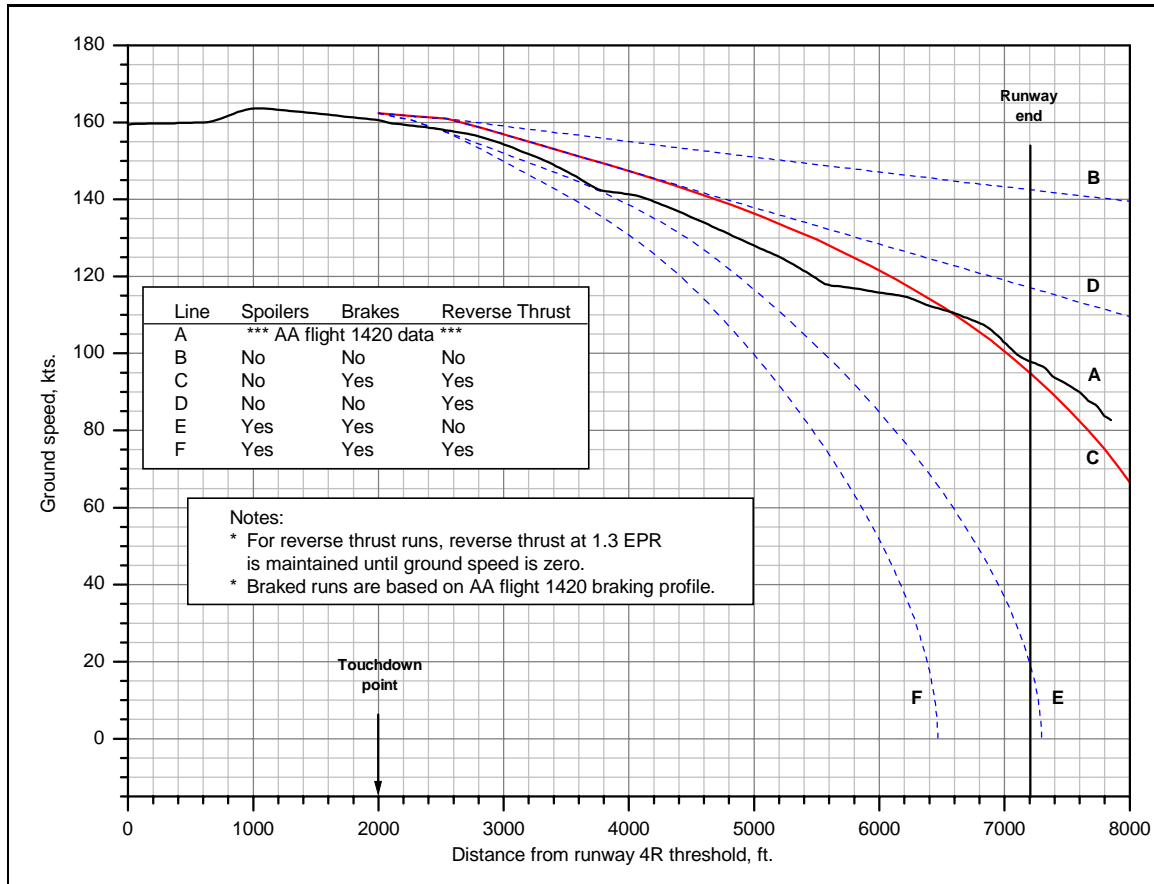
**Figure 16.** Effects of Spoilers, Brakes, and Reverse Thrust on Stopping Distance

With no braking, spoilers, or reverse thrust, the airplane would depart the runway with a ground speed of about 142 knots, which is 45 knots faster than the flight 1420 airplane. With no spoilers or brakes but with a constant, symmetrical reverse thrust at

1.3 EPR, the airplane would leave the runway at 117 knots, which is 20 knots faster than the flight 1420 airplane. With no spoilers but with 1.3 EPR reverse thrust and the flight 1420 braking profile, the airplane would have departed the runway at 95 knots. This computer run matched the flight 1420 data best and indicated that the accident airplane experienced a braking coefficient of at least 0.21 to 0.23 at speeds between 160 and 140 knots, respectively.<sup>96</sup> Figure 16 shows the results of the computer runs compared with the flight 1420 profile.

Two additional computer runs demonstrated that proper spoiler deployment is critical to deceleration and stopping distance. Without reverse thrust and with the spoilers deployed and the flight 1420 braking profile, the airplane would depart the runway at 20 knots, which is 75 knots less than the airplane with no spoilers but with reverse thrust and braking. With constant reverse thrust, deployed spoilers, and the flight 1420 braking profile, the airplane could have stopped about 700 feet before the end of the runway.

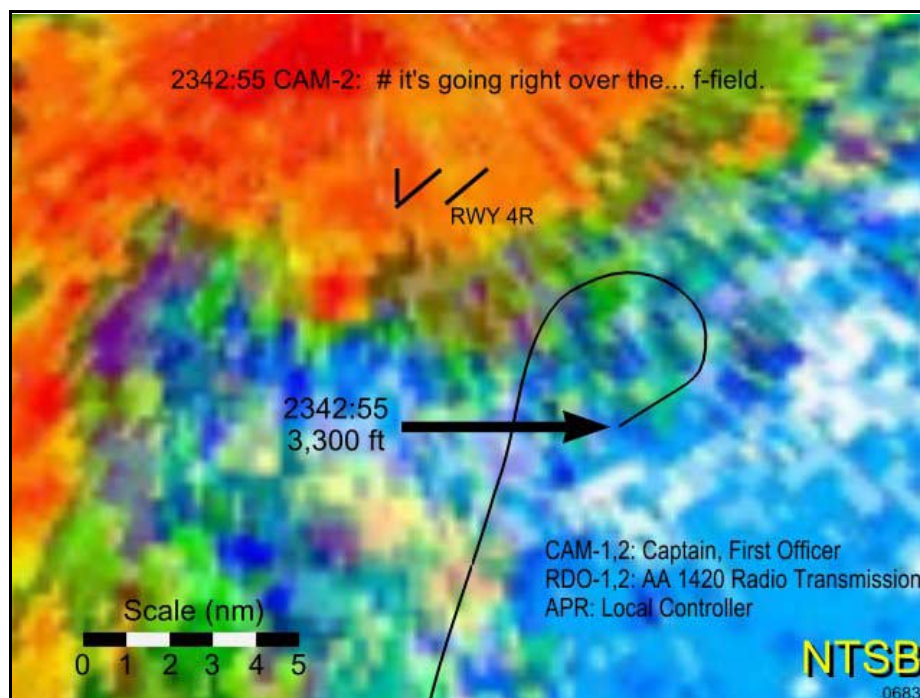
**Figure 20.** Weather and Flight Information for 2342:55

The flight crew continued to receive, but did not discuss, wind reports from the controller. The flight crew's actions and conversations during this phase of the approach largely consisted of steps to expedite the approach to the airport. For example, at 2342:40, the first officer asked the captain if he wanted to conduct a "short approach" and "keep it in tight." The captain accepted the suggestion but with the qualification "if you see the runway, 'cause I don't quite see it." (The airport was off the right, or first officer's, side of the airplane.) The first officer began to radio the controller at 2342:54 to suggest a visual approach but interrupted this transmission 1 second later when he stated to the captain, "it's going right over the...field." In a postaccident interview, the first officer indicated that he was referring to a temporary obstruction of his view of the airport because of clouds. The first officer's next transmission, 4 seconds later, informed the controller that "we got the airport" and that "we're going between clouds." Figure 20 shows a map of the weather conditions at 2342:55 and flight 1420's location.

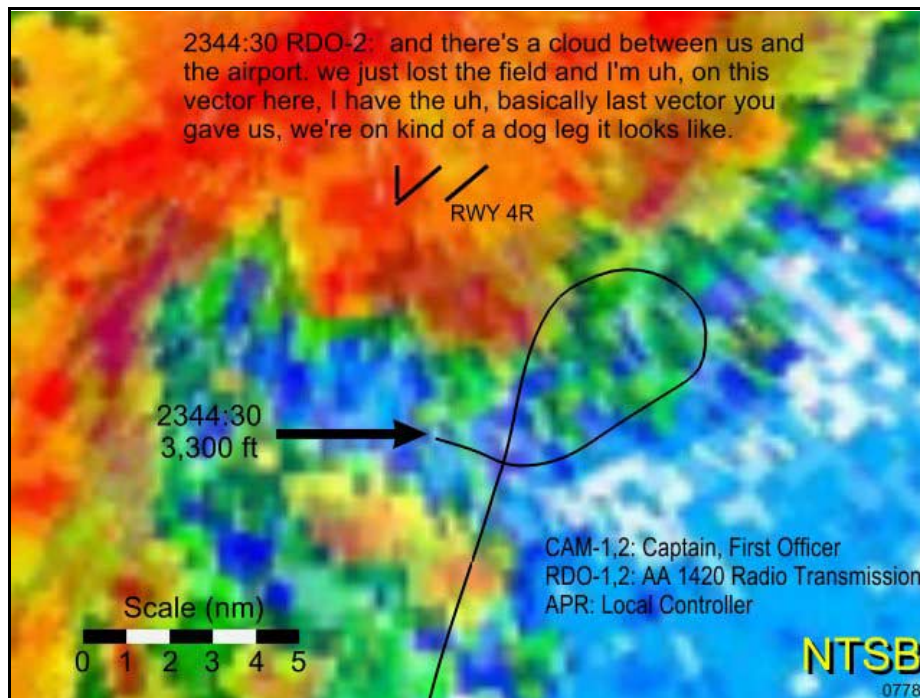
**Figure 21.** Weather and Flight Information for 2344:30

At 2344:19, the captain stated, "see we're losing it. I don't think we can maintain visual." The first officer notified the controller at 2344:30 that visual contact with the airport had been lost because of a cloud between the airplane and the airport. The controller then cleared the airplane to fly a heading of 220° for radar vectors for the ILS approach to runway 4R. (ATC radar indicated that, at this time, flight 1420 was about 6 miles south of runway 4R, heading westbound and away from the runway. Weather radar data indicated that heavy rain was occurring at the airport at the time that the airplane was flying on the 220° heading.) Figure 21 shows a map of the weather conditions at 2344:30 and flight 1420's location.

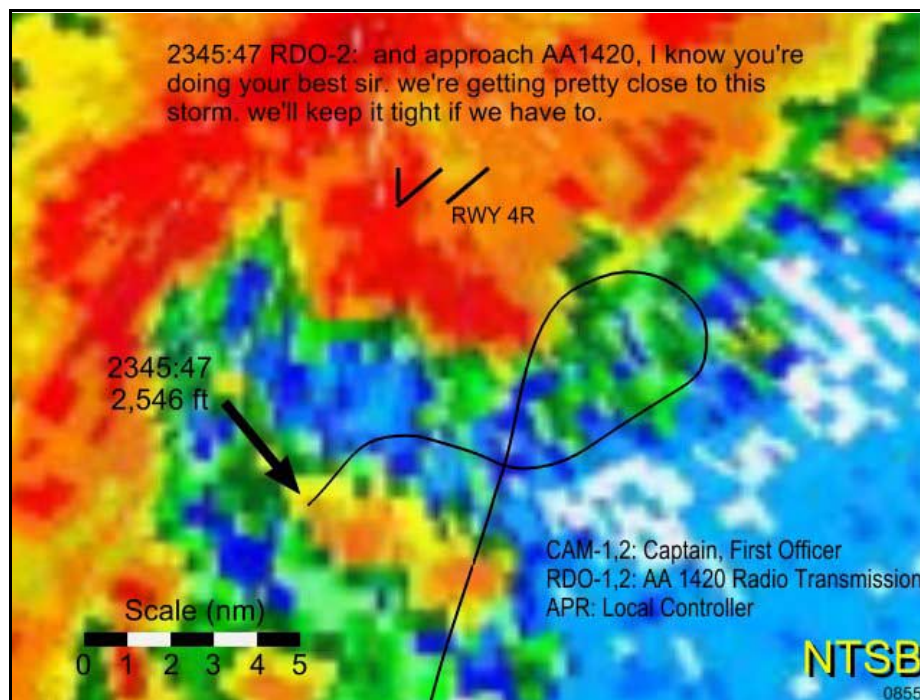
**Figure 22.** Weather and Flight Information for 2345:47

The weather south of the airport became the next focus of the flight crew's attention. NWS radar data indicated that, in the 6 minutes before the accident, a line of thunderstorms, with several large areas of intense and extreme activity, was encompassing the Little Rock airport area and runway 4R approach path. At 2345:47, the first officer told the controller "we're getting pretty close to this storm. we'll keep it tight if we have to." The controller indicated to the flight crew that, "when you join the final, you're going to be right at just a little bit outside the marker if that's gonna be okay for ya." The captain stated, "that's great," and the first officer told the controller, "that's great with us." Figure 22 shows a map of the weather conditions at 2345:47 and flight 1420's location.

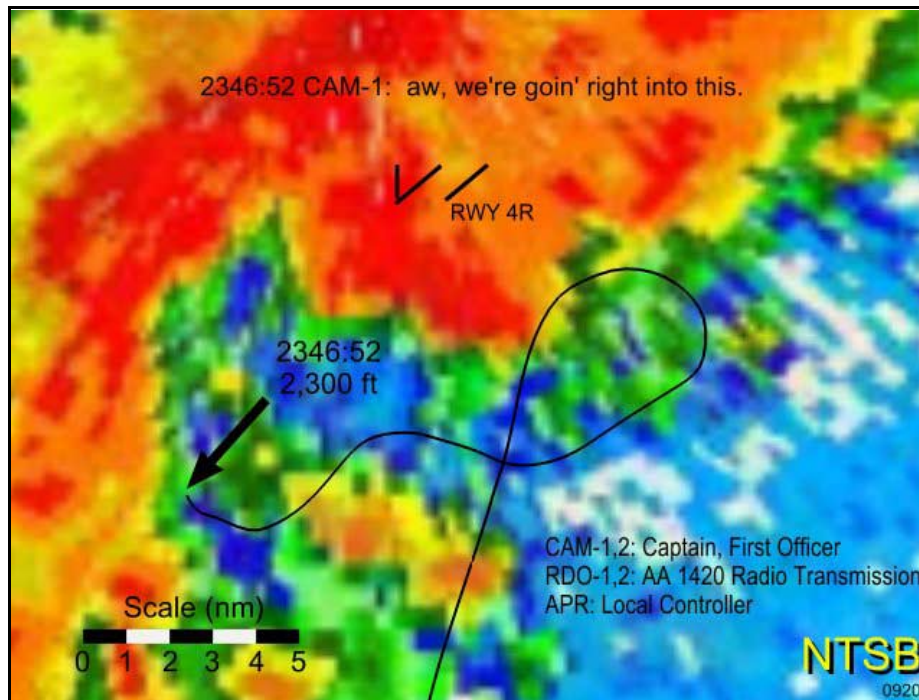
**Figure 23.** Weather and Flight Information for 2346:52

At 2346:52, the controller advised the flight crew that heavy rain was falling at the airport, visibility was less than 1 mile, ATIS information Romeo was no longer current, and the runway visual range (RVR) was 3,000 feet. Simultaneously, the captain

stated, “aw, we’re goin’ right into this.” Figure 23 shows a map of the weather conditions at 2346:52 and flight 1420’s location. About this point in the approach, the flight crew should have regained the use of the airborne weather radar to depict precipitation levels in front of the airplane. However, the Safety Board could not determine whether the radar was displaying this information or whether the flight crewmembers, given their workload, were able to perceive and interpret the information that the radar was providing.

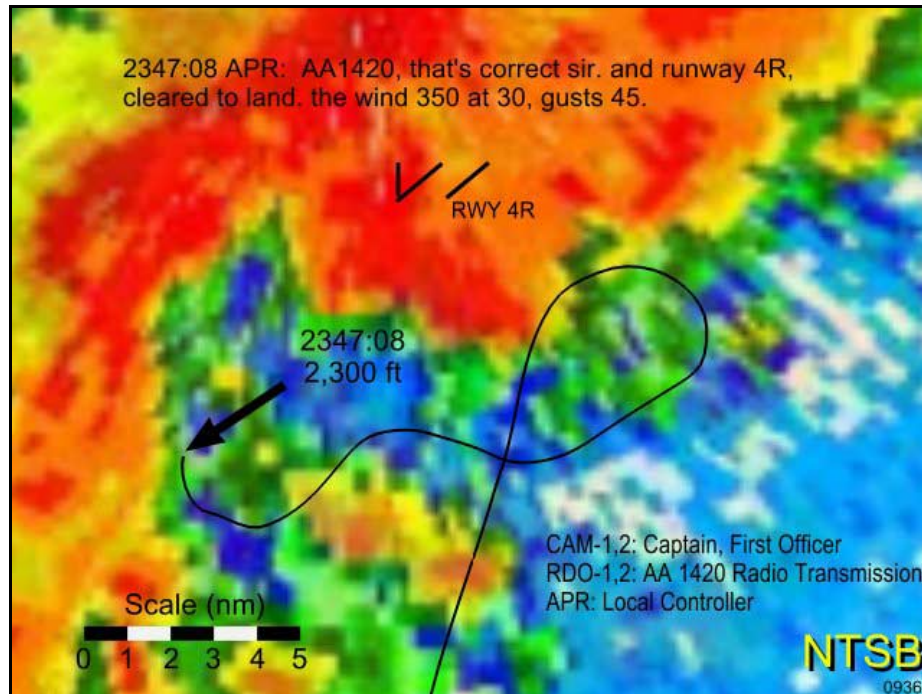
**Figure 24.** Weather and Flight Information for 2347:08

At 2347:08, the controller cleared flight 1420 to land and stated that the wind was 350° at 30 knots gusting to 45 knots. The CVR indicated that flight crew did not discuss the wind information, the heavy rain that was already falling at the airport, or the depiction of the weather on the airborne weather radar. Figure 24 shows a map of the weather conditions at 2347:08 and flight 1420’s location.

Statements from the CVR and the first officer’s postaccident interviews indicated the flight crew’s concern about the location of the thunderstorm in relation to the airport and the airplane. However, the Safety Board concludes that, because the first officer was able to maintain visual contact with the runway as the airplane was vectored for the final approach course, both flight crewmembers might still have believed that flight 1420 could arrive at the airport before the thunderstorm. The Board understands that some other flight crews might continue an approach to a runway under the same circumstances. On the other hand, the Board also recognizes that the approaching storm and the reports of heavy rain, dropping visibility, and increasing crosswinds (from 10 to 30 knots with

gusts to 45 knots) would be sufficient for some flight crews to hold until the storm passed or proceed to an alternate airport.

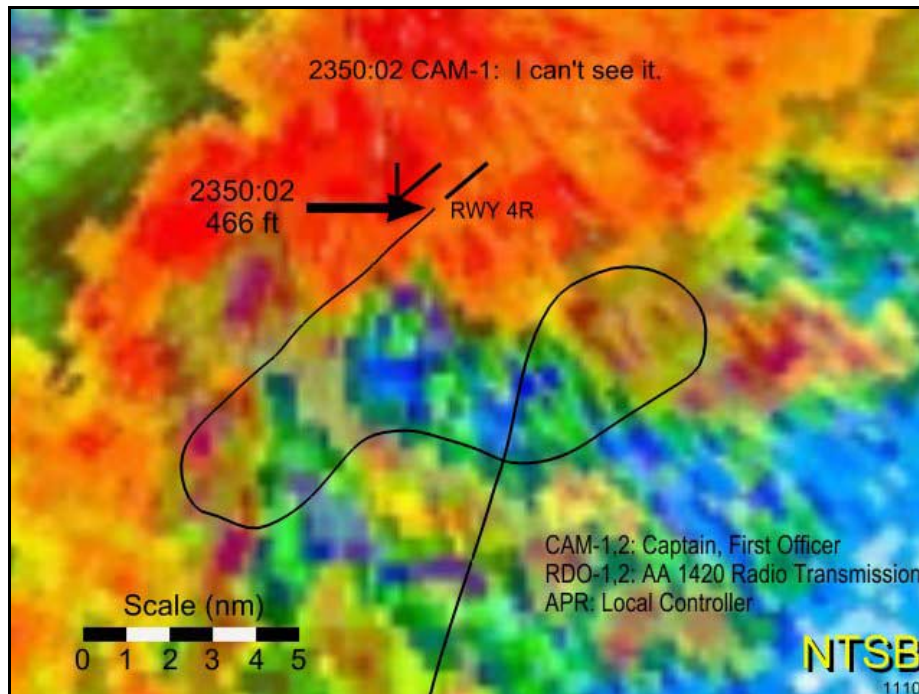
**Figure 26.** Weather and Flight Information for 2350:02

At 2350:02, the captain stated, "I can't see it." Calculations based on FDR data indicated that the airplane was between 5 and 20 feet above the decision height at that time. The Safety Board was not able to determine whether the captain's comment referred to his loss of visual contact with the runway or with its environment. Figure 26 shows a map of the weather conditions at 2350:02 and flight 1420's location.
