3406 B/C PEEC Repair Manual

**3406B – 8TC
3406B – 5YG
3406B – 2EK
3406C – 4CK**

3406 PEEC Introduction

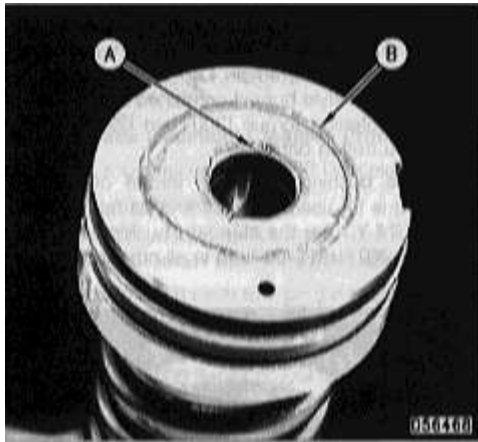
Illustration 1. Top View Of Barrel

A. Do not reuse if the check valve seating surface is nicked.

B. Staining here is acceptable. The new bonnet seal ring is inside this diameter. There is no need to remove light to moderate stains in this area.

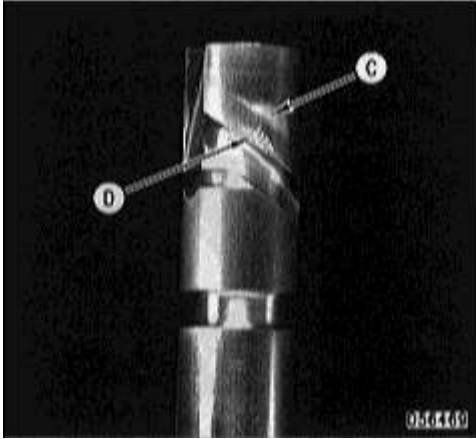
Illustration 2. Plunger

- C. Cavitation erosion above the scroll edge is acceptable.
- D. Plungers with worn or nicked scroll edges should not be reused.

NOTE: Do NOT mix plungers and barrels. The original plungers must remain with the same barrels. If the plunger is not acceptable, a new pump group is required. Do not proceed with this process if the plunger is not acceptable.

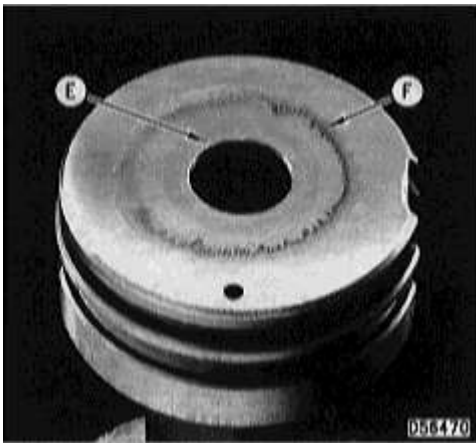
Illustration 3. Top View Of Barrel

- E. A mirror image of the check valve notch is acceptable.
- E. Heavy staining should be removed to prevent debris from getting into the sealing joint during assembly. Visible staining "Not Easily Removed" is acceptable because the new bonnet seal ring is inside this diameter.

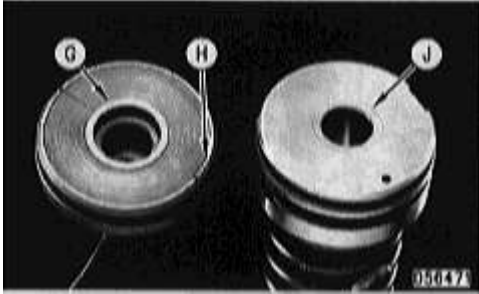
Illustration 4. Bottom View Of Bonnet (Left). Top View Of Barrel (Right)

G. This style bonnet can have staining removed with the same cleaning process and reused.

H. Multiple relief notches are acceptable.

J. Light staining and fretting is not an automatic indication of joint leakage. This should be cleaned before reuse.

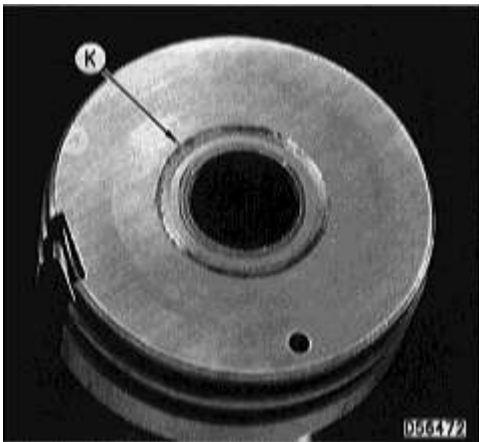
Illustration 5. Top View Of Barrel

K. Staining and/or fretting "Before" cleaning.

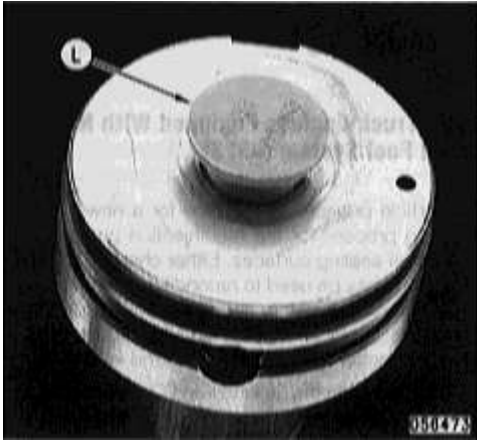
Illustration 6. Top View Of Barrel

L. A 7000 Series nozzle tip cap in the barrel bore will help keep the cleaning fluid on the surface. Remove the cap and flush the barrel with clean diesel fuel after cleaning. The chemical cleaning will remove surface stains, but fretting will remain. Laboratory and field test indicate a new style bonnet combined with increased bushing tightening torque [300 N·m (220 lb ft)] will seal with a fretted barrel.

NOTE: The bushing tightening torque of 300 N·m (220 lb ft) is for used plungers and barrels with face fretting ONLY. Use the standard bushing tightening torque of 260 N·m (190 lb ft) in all other cases.

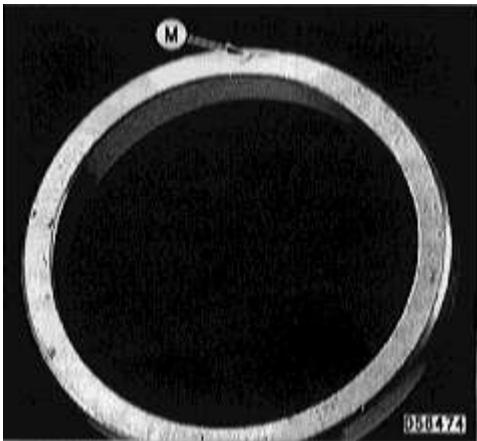
Illustration 7. Timing Spacer

M. Debris dent in a timing spacer. Do not reuse. Manufacturing grind marks are acceptable and lapping is not required.

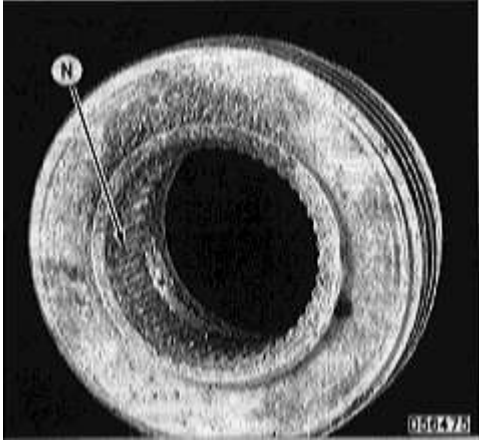
Illustration 8. Bushing

N. Do not reuse bushings with heavy amounts of spline rust. The splines must be in good condition to maintain the tightening torque. The splines must be in good condition to maintain the tightening torque. Number the bushings as they are removed so they can be reinstalled in the same bores.

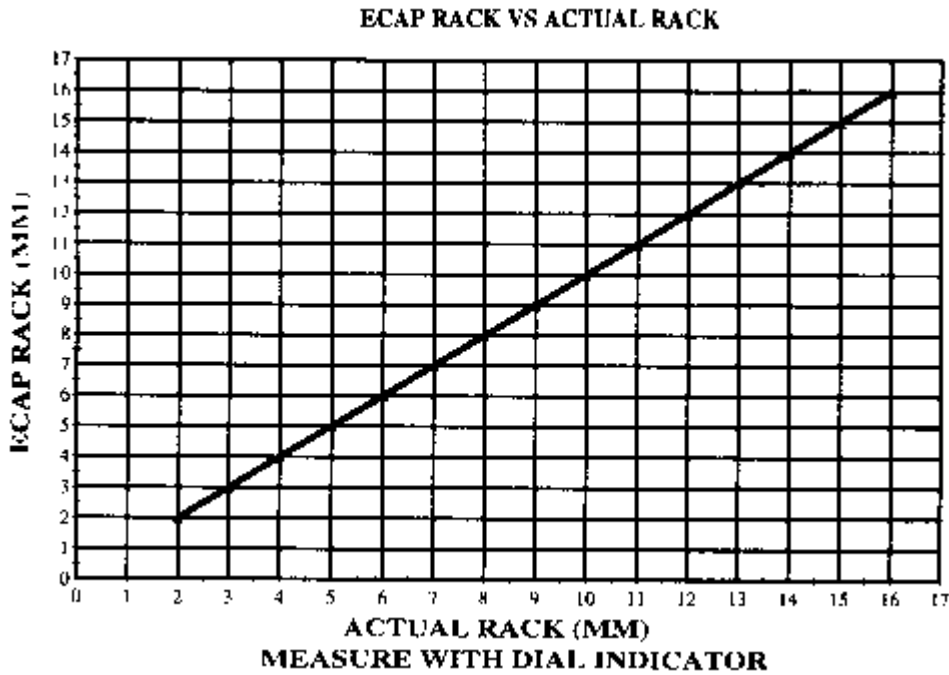
Graph 1.

Graph 1 reflects a linear (straight line) output generated by a rack sensor functioning properly. Two types of non-linearity have been identified to date. Graph 2 shows a slight non-linearity at the end of the rack travel, but would probably not cause the engine to have excessively low power. The second example of non-linearity is shown in Graph 3. This type of output would result in the low power, fuel rate and boost levels mentioned previously. Replacement of the rack sensor may be necessary to restore the engine to its normal power levels if the rack values obtained simulate those shown in Graphs 2 and 3.
