3406 B/C PEEC Repair Manual

**3406B – 8TC
3406B – 5YG
3406B – 2EK
3406C – 4CK**

3406 PEEC Introduction

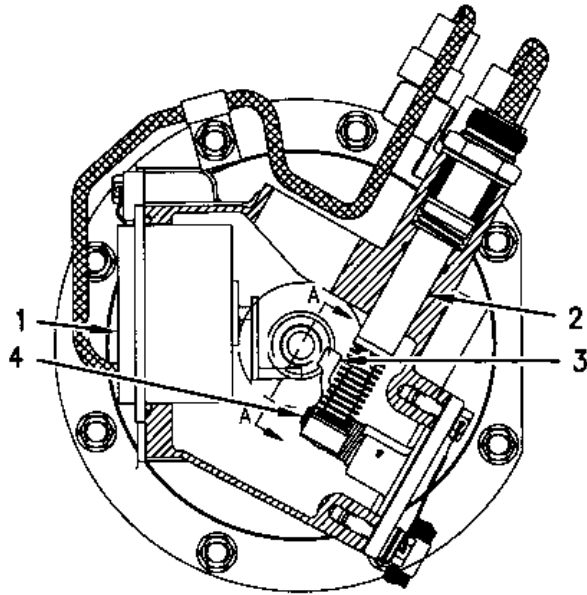
D17131

- * Check arm to shaft joint for damage.
- * Check the solenoid part number. The former 9X-6770 Solenoid has been replaced by the new 105-2939 Solenoid. The new solenoid has a stronger shaft. This change is effective with S/N 4CK2537.

2. Check control group (timing sensor) for a loose tip. See Illustration 1, Item 2.

- * Check for loose tip.
- * Put 9S-3263 Thread Lock of the threads of the 9X-9555 Control Group (timing sensor) before it is installed. This change is effective with S/N 4CK6001.
- * The 118-7204 Sensor Tip Kit is available for repairing or replacing the sensor tip.

- * Check the faces of the bell crank to be sure that no excessive wear has occurred.
- * Check round area of the bell crank to be sure the spring is not causing galling of the bell crank on the pivot pin.
- * The 2W-3623 Bell crank Assembly pin depth is correct effective with S/N 4CK11473.
- * Bell crank endplay should be .13 to .64 mm (.005 to .025 in).

Illustration 1. Timing Control Group components. Solenoid (1). Control Group (2). Bell crank Assembly (3). Pin (4).

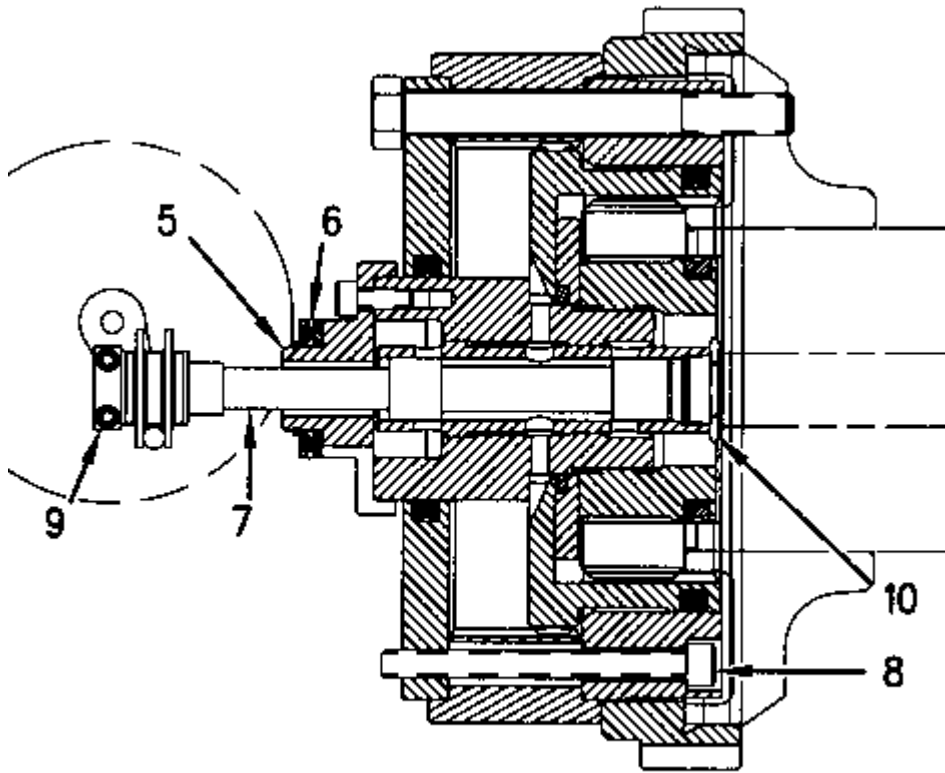
D17168

- * Check the thrust bearing face and the front of the 2W-3635 Sleeve for wear caused by the bell crank being out of position with respect to the thrust bearing.

* Check spool for damage and part number.

7. Check to be sure the former 3P-3547 Retaining Ring has been replaced by the new 108-4511 Clamp Assembly. See Illustration 3, Item 9.

Illustration 3. Governor And Fuel Pump Drive Group components. 2W-3635 Sleeve Assembly (5). Thrust bearing (6). 4P-3384 Spool (7). 6J-2819 Bolts (8). 108-4511 Clamp Assembly (9). 101-1942 Plug in 101-1944 Carrier Assembly (10).

* Replace former 4W-2750 or 7E-5564 Spool with new 4P-3384 Spool. The new spool is effective with S/N 8TC13234.

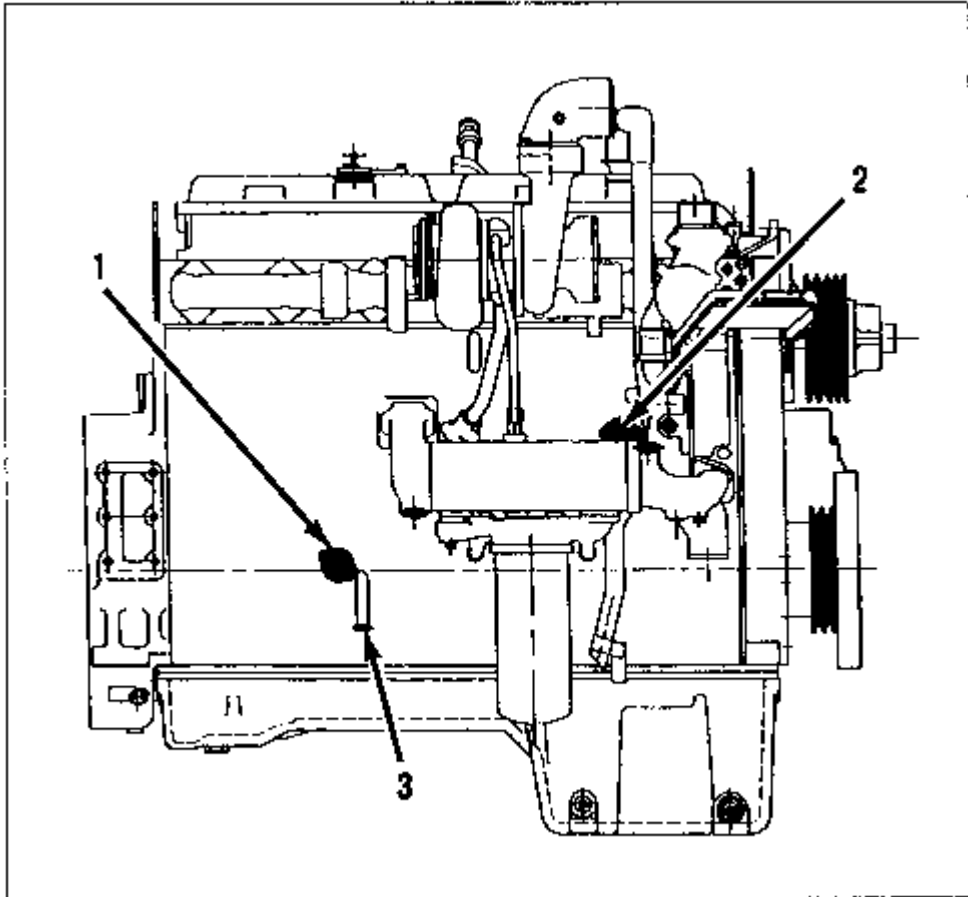
Locations to add oil for dipstick calibration. Location 3 is one of three plugs in unused oil level gauge locations.

- 1.** Drain a hot engine for 20 minutes. Remove BOTH shallow sump and deep sump drain plugs.
- 2.** Remove the oil filter.
- 3.** Install the drain plugs removed in Step 1.
- 4.** Install a new DRY oil filter.
- 5.** Add 28 quarts (7 gallons) of CF4 oil to the engine at locations 1, 2, or 3. **ONLY THESE FILL LOCATIONS SHOULD BE USED WITH THIS PROCEDURE.** (See the illustration.)

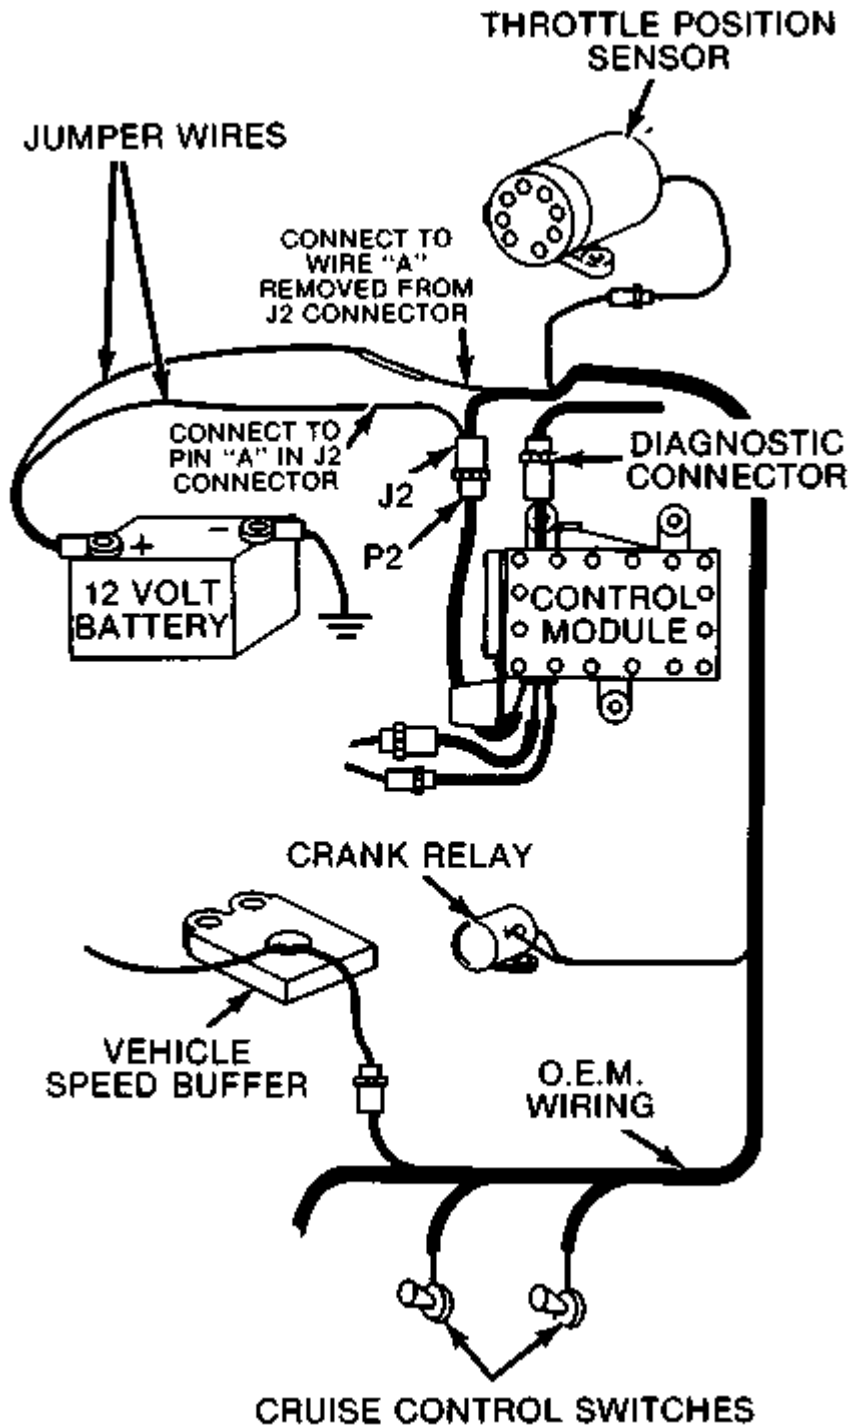
Reports indicate a problem servicing and programming a 3406B (PEEC) Truck Engine equipped with a Kysor ® Engine Shutdown System. The Kysor® Engine Shutdown disconnects the Programmable Electronic Engine Control (PEEC) voltage supply when the engine is without oil pressure for a specified amount of time (approximately 30 seconds). This results in an inability to program and service the PEEC system.

1. Remove the "A" wire from the J2 connector with a Deutsch pin remover (part to the 1U5803 Deutsch Connector Repair Kit).
2. Attach an 8T8729 Pin to a 16 AWG jumper wire and insert the pin into "A" position of the J2 connector.
3. Connect the other end of the jumper wire to a battery positive (+) source.
4. Connect power to the Throttle Position Sensor and the Vehicle Speed Buffer. In most cases (dependent on OEM wiring) this can be done by connecting a jumper wire from a battery positive (+) source to "A" wire removed in Step 1. An 8T8730 Socket can be used to connect the jumper wire to the 8T8729 Pin on the end of wire "A".

NOTE: Be sure to keep all contacts isolated from any grounded surface.
