## AIRCRAFT ACCIDENT REPORT

RUNWAY OVERRUN DURING LANDING  
AMERICAN AIRLINES FLIGHT 1420  
MCDONNELL DOUGLAS MD-82, N215AA  
LITTLE ROCK, ARKANSAS  
JUNE 1, 1999

**NTSB/AAR-01/02  
PB2001-910402  
Notation 7195A  
Adopted October 23, 2001**

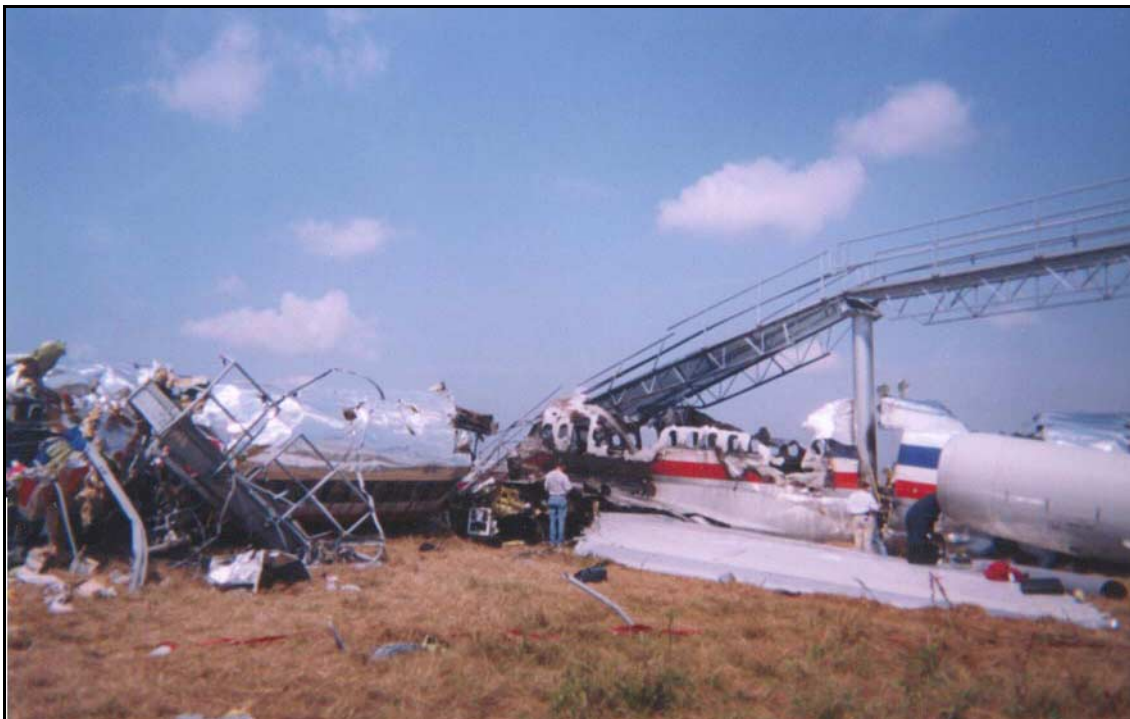
**Figure 14.** View of Left Side of Airplane Wreckage and Runway 22L Approach Lighting System

Figures 12 through 14 are photographs of the airplane wreckage. Figure 12 shows the airplane wreckage, the tire tracks off the end of runway 4R, and the damage to the runway 22L approach lighting system.<sup>77</sup> Figure 13 shows the airplane wreckage and the runway 22L approach lighting system. Figure 14 shows a closer view of the airplane and the runway 22L approach lighting system. Additional details about the airplane wreckage are presented in sections 1.12.2 through 1.12.4.
