Entune Audio Head Unit Software Update (Panasonic)

Service Category Audio/Visual/Telematics

Section Navigation/Multi Info Display

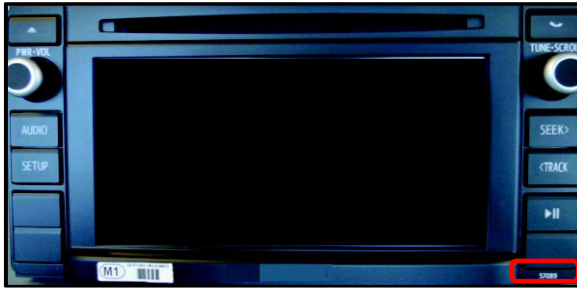
1. Confirm the audio system type by checking the Panel ID printed on the bottom-right or bottom-center of the machine.

Figure 1. Avalon, Avalon HV, Highlander, Highlander HV, Prius V, Sienna, Sequoia, Tacoma & Tundra.

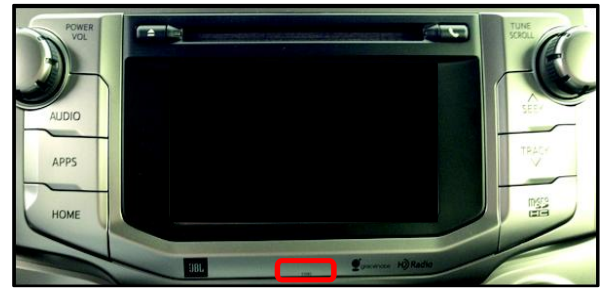
Figure 2. 4Runner

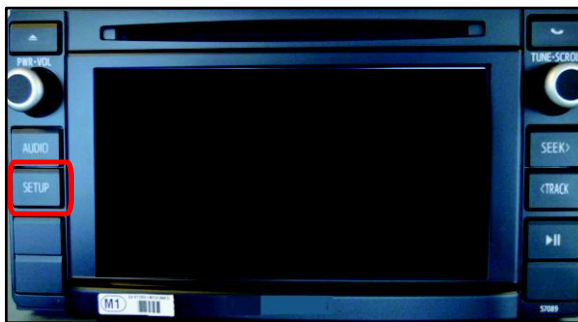
2. Start the engine.
 3. Go to the *Setup* screen.
- A. **For Entune™ Audio:**
 Press the **SETUP** button on the panel.

Figure 3. 4Runner, Highlander, Highlander HV, Sequoia, Tacoma & Tundra

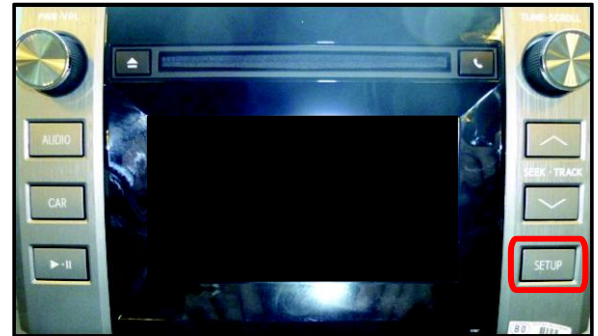
Figure 4. 4Runner

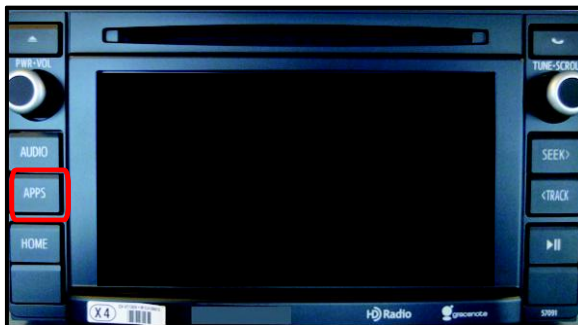
- (1) Press the *APPS* button on the panel.

Figure 5. 4Runner, Highlander, Highlander HV, Sequoia, Tacoma & Tundra

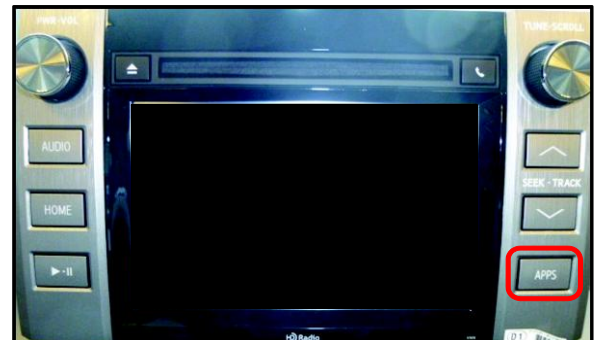
Figure 6. Tundra

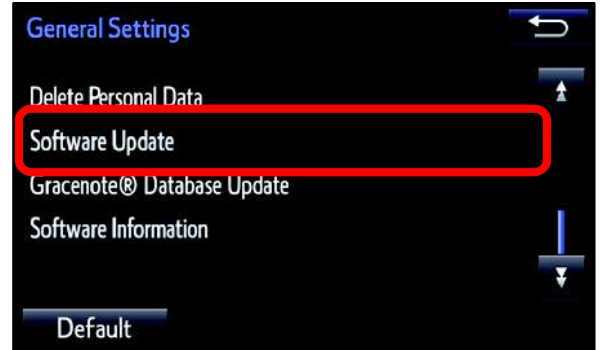
Figure 10.

5. Select *Software Update* from the list on the *General Settings* screen.

Scroll down the list until *Software Update* is displayed.

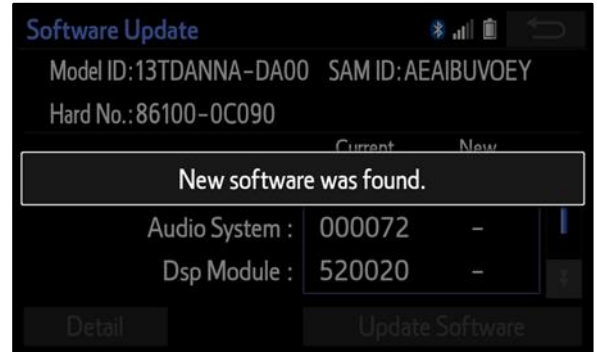
Figure 12.

If software has been detected properly, a "New software was found." Pop-up will be displayed.

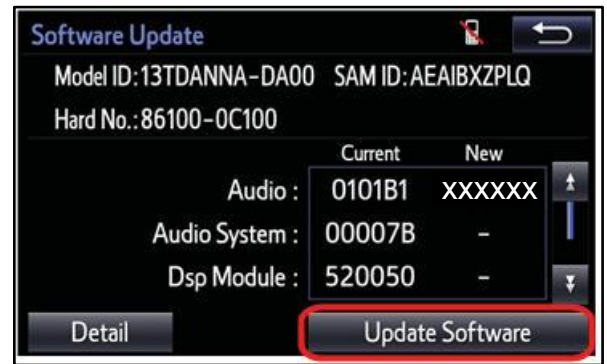
Figure 13.

- Verify that the new software is up-to-date on the *Software Update* screen.

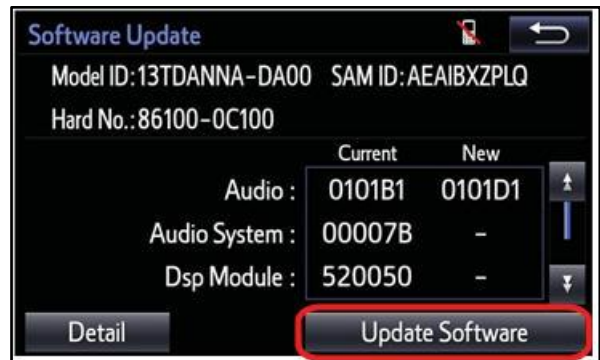
Figure 14.

- Select *Update Software* on the *Software Update* screen.

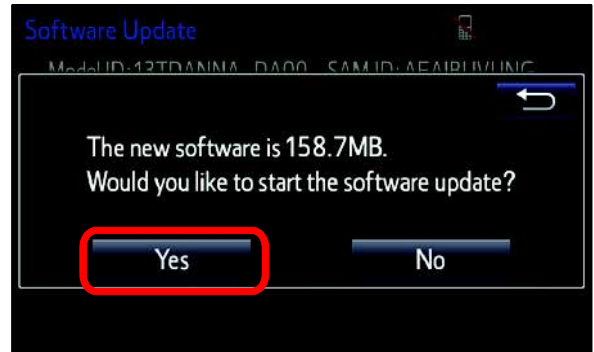
Figure 15.

9. Select Yes on the “Would you like to start the software update?” pop-up.

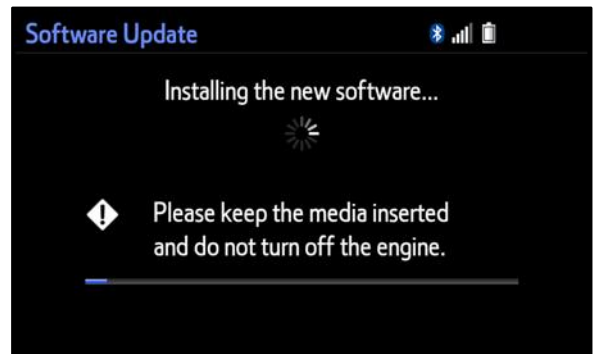
Figure 16.

10. The unit begins installation. The update will take about 10 minutes.

- Do NOT turn off the engine or ACC before the software is ready for updating.
- Do NOT pull the USB Drive SST out of the vehicle USB port.

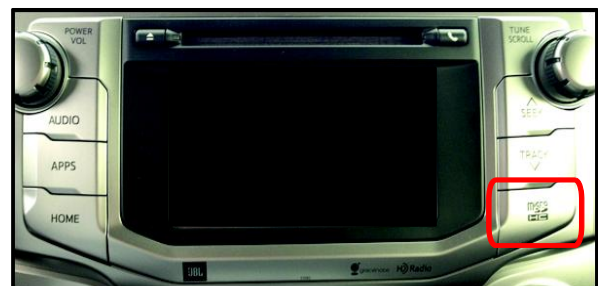
Figure 17.

If update fails and the error message “New software is not compatible with the system.” displays, cycle the ignition OFF, remove the Map Micro SD Card from the head unit, and repeat steps 2 – 11.

Once update is complete, reinsert the Map Micro SD card into the head unit, cycle the ignition OFF, and proceed to step 13.

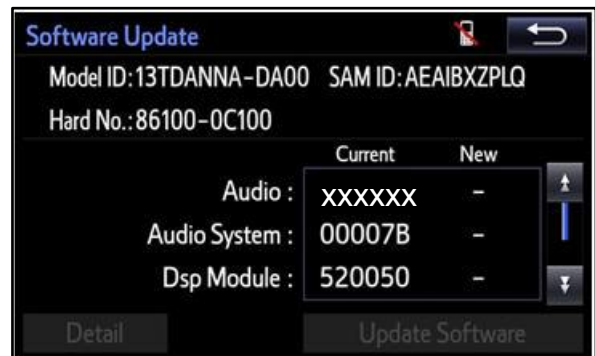
Figure 19.

1. Perform steps 3 – 7 of the Software Update procedure to re-enter the *Software Update* screen.
2. Verify that the software information is updated on the *Software Update* screen.
